Improvements to the Hamilton, Glover, and Sarmiento statue nodes

Landmarks Commission Continuance | 4.27.2021

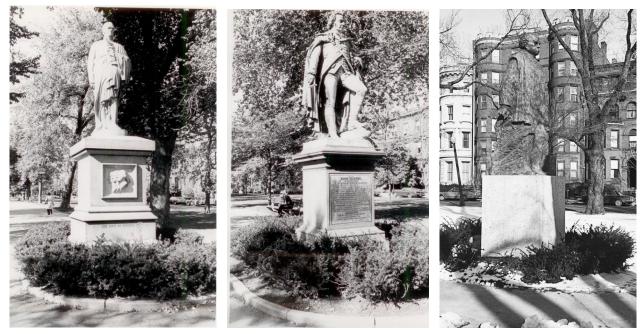
CURB CONSISTENCY: HISTORIC CONDITIONS

Hamilton, Glover, and Sarmiento statues, as issued in the 1975 Landmarks Commission report

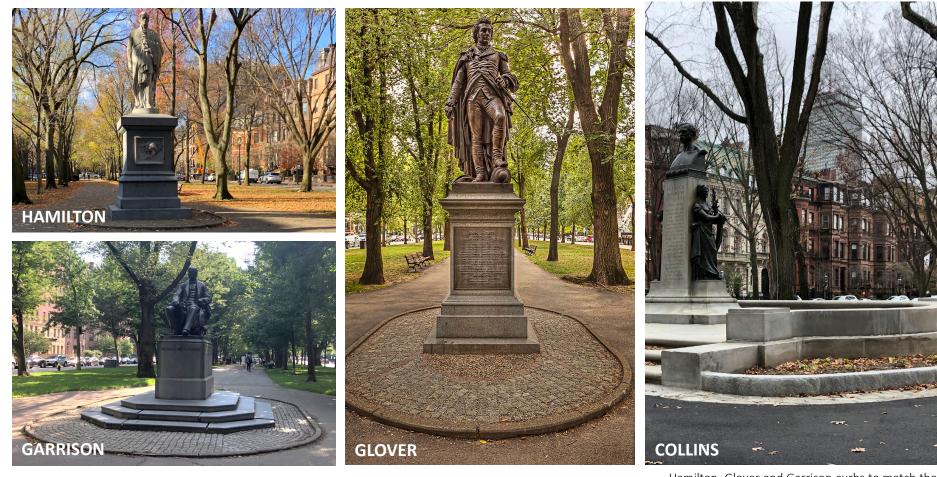
VARYING STYLES: HAMILTON, GLOVER, GARRISON & COLLINS

Hamilton, Glover and Garrison curbs to match the new beveled curb at the Collins statue

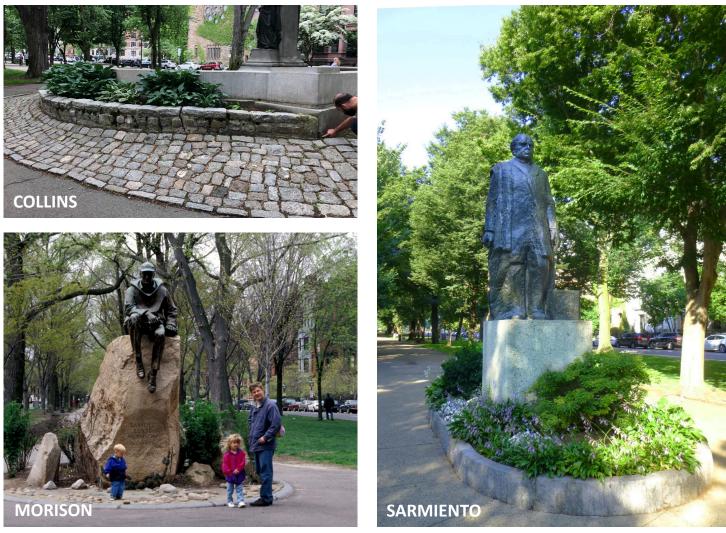
PLANTING CONSISTENCY: COLLINS, MORISON, & SARMIENTO

(Top): Planting, pre-construction (Bottom): Original approved planting
