### EXISTING PHOTOS

### FRONT ELEVATIONS

7 - 9 Newbury Street Rear Alley Existing Conditions

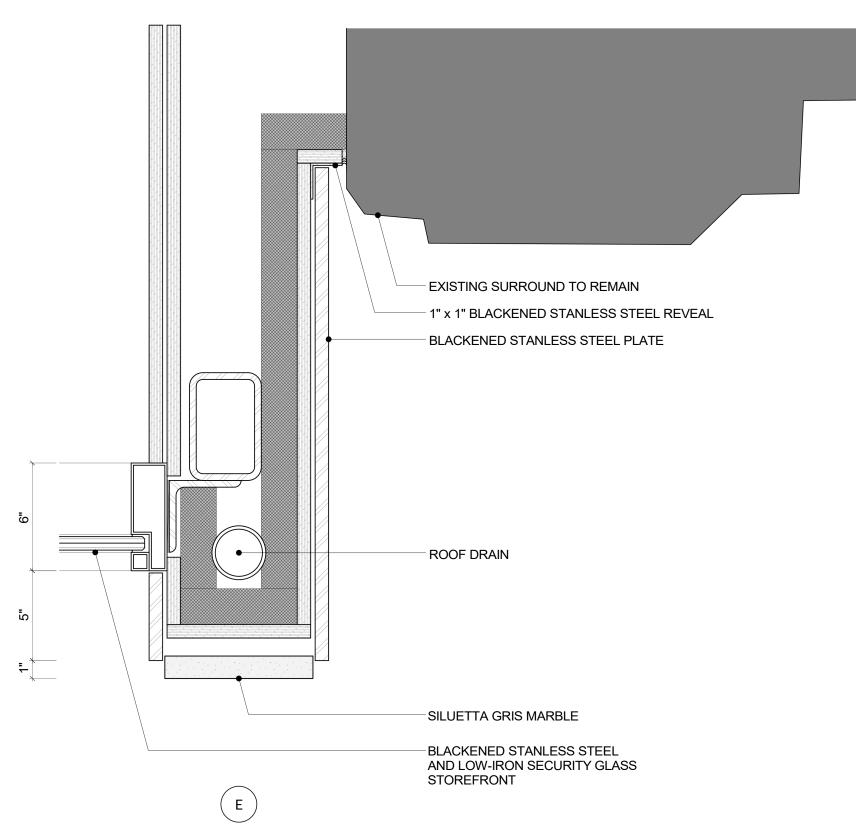
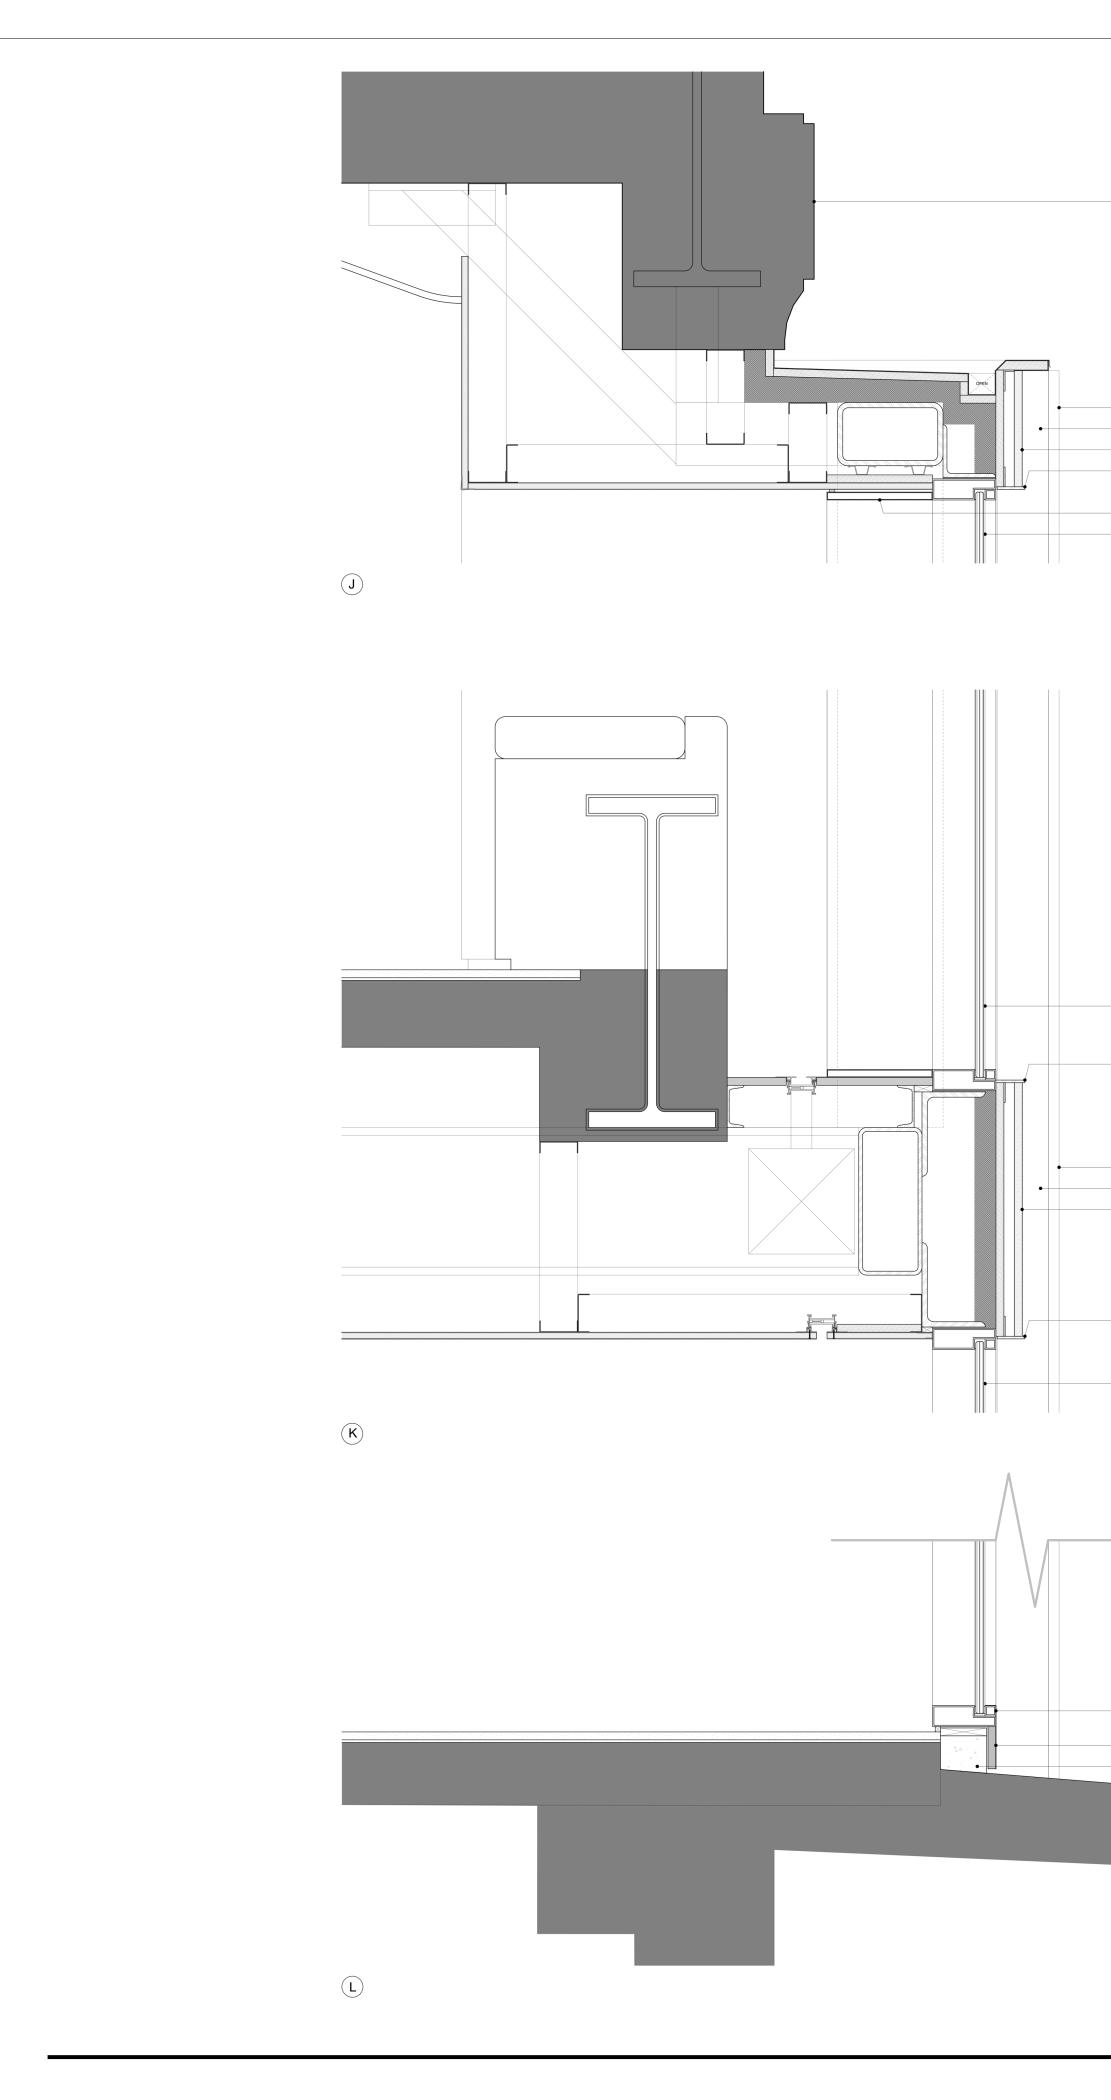
#### DETAILS

#### EXISTING SURROUND TO REMAIN

—SILUETTA GRIS MARBLE —BLACKENED STANLESS STEEL PLATE

-TUNDRA GREY MARBLE -BLACKENED STANLESS STEEL PLATE

BLACKENED STANLESS CLAD PANEL BLACKENED STANLESS STEEL AND LOW-IRON SECURITY GLASS STOREFRONT

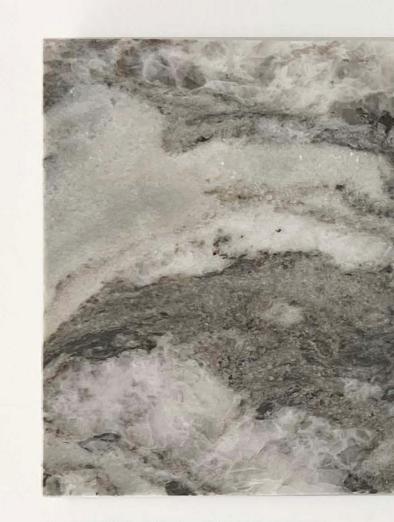
SILUETTA GRIS - FLURRY CUT HONED MARBLE

BLACKENED STANLESS STEEL AND LOW-IRON SECURITY GLASS STOREFRONT

-BLACKENED STANLESS STEEL PLATE

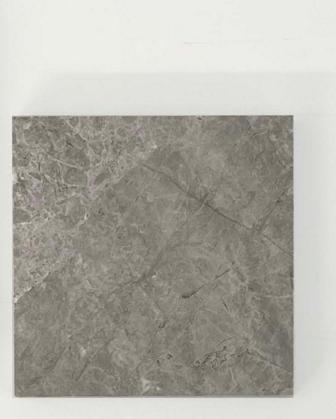
#### DETAILS

TUNDRA GRAY

BLACKENED STAINLESS STEEL

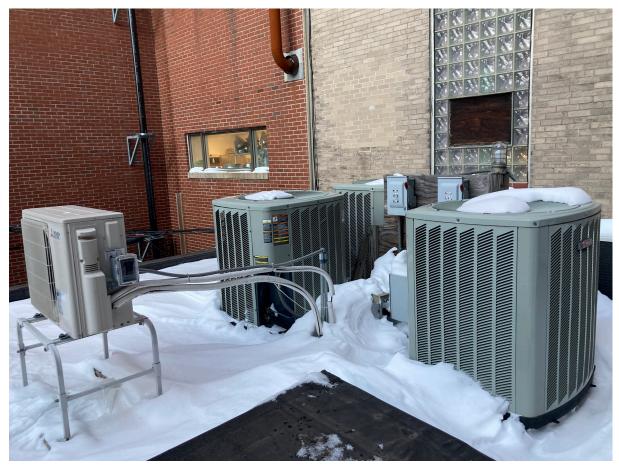
7 - 9 Newbury Street Rear Alley Roof Existing Compressors

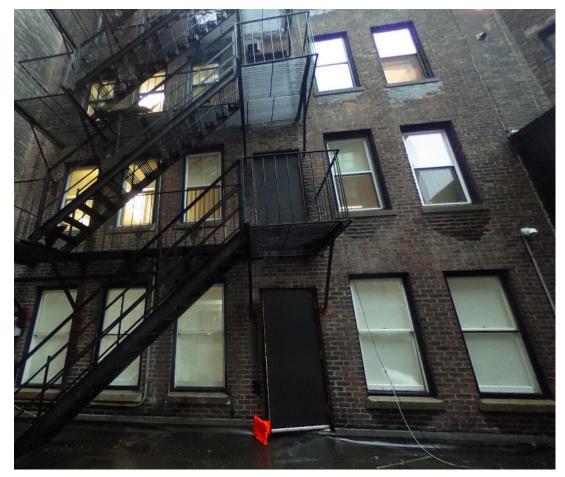
7 - 9 Newbury Street Rear Alley Roof Existing Fire Escape
