148 Worcester St. Unit 5  
Window Replacement

**APP # 23.0635 SE**

*Removal:* (3) non-historic wood & aluminum clad windows due to rot, seal failure and draft.

*Replace:* In-kind; (3) Pella Reserve wood & aluminum clad windows. Putty glaze sash profile.

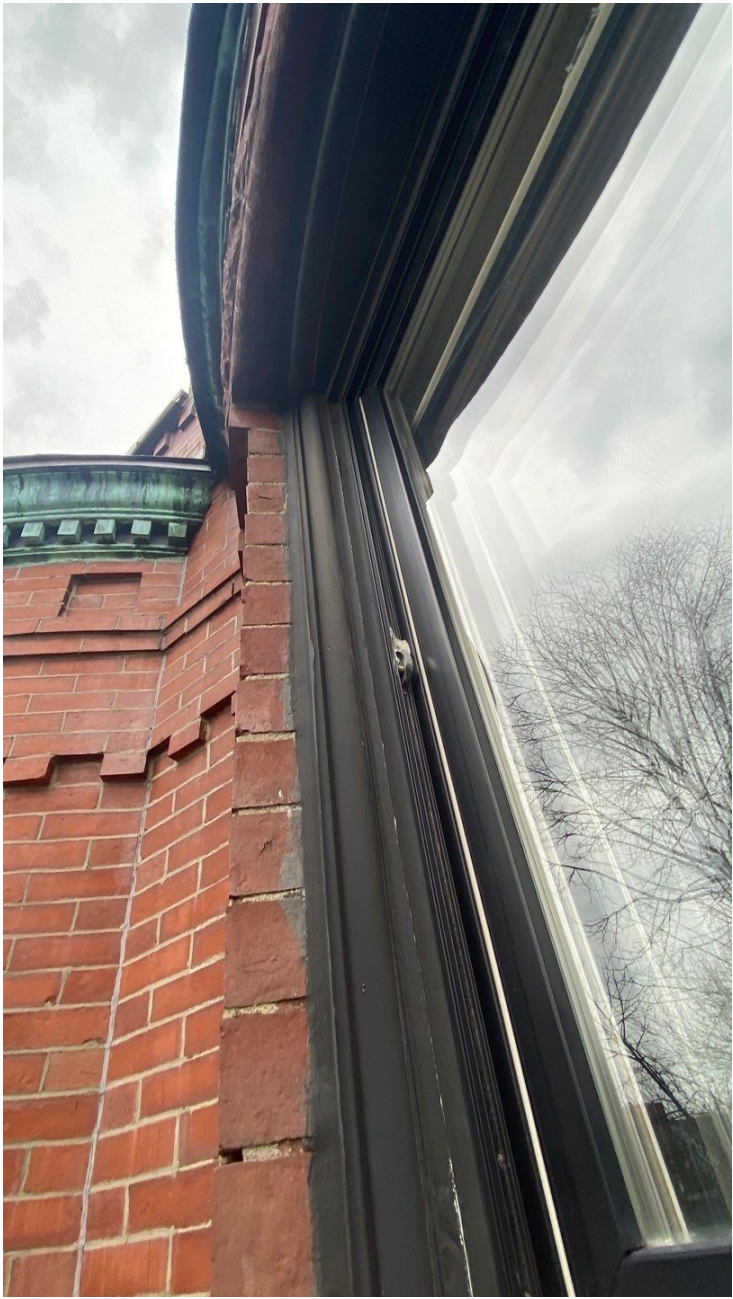
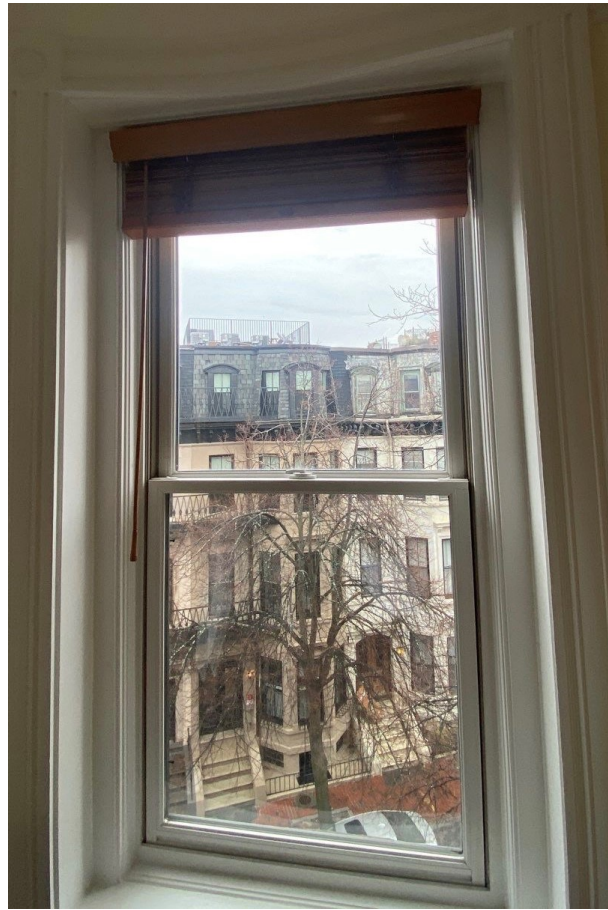
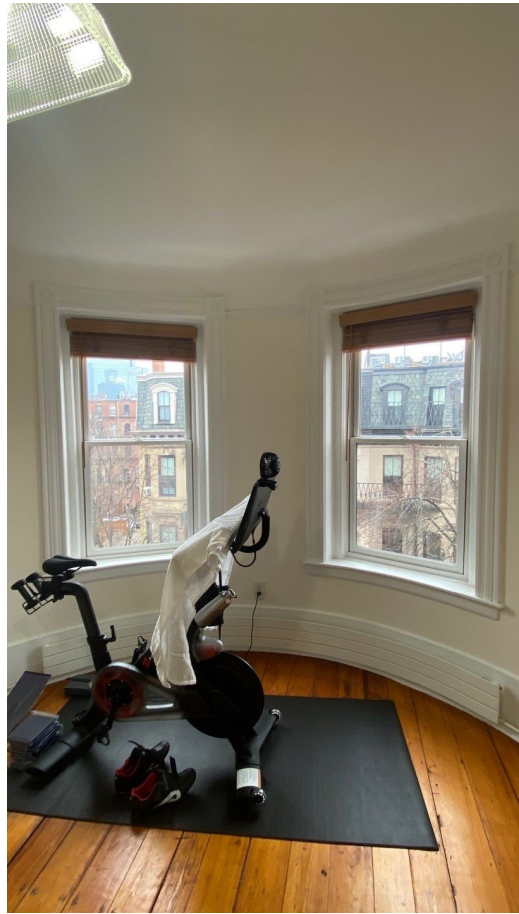
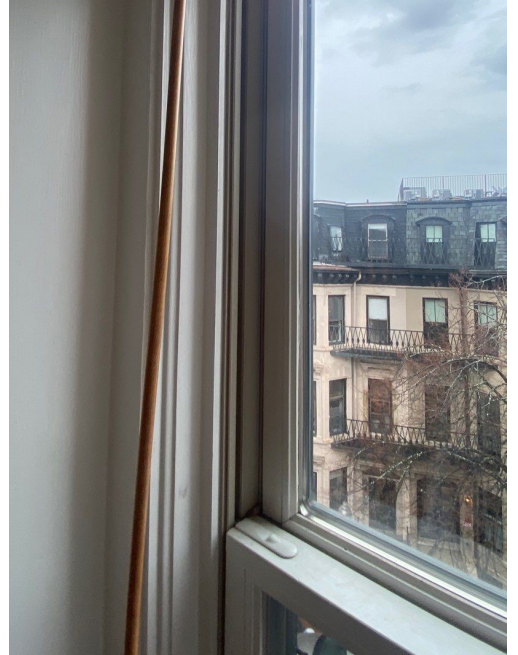
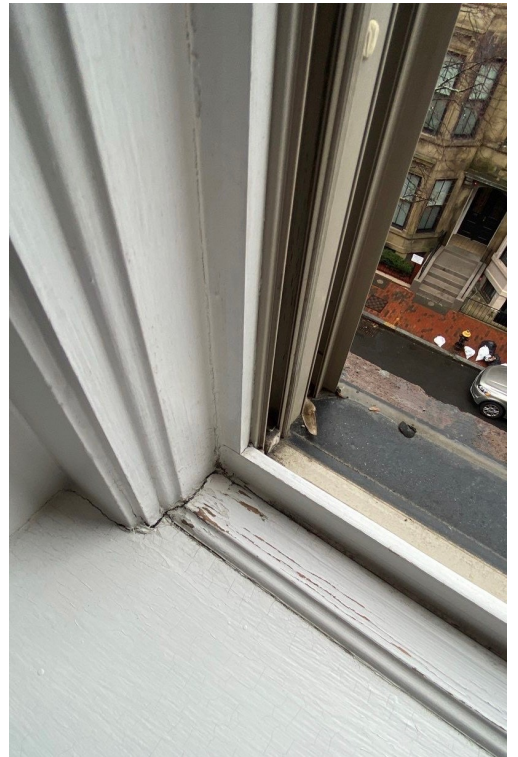
Unit Sections - Aluminum-Clad Putty Glaze Exterior Profile

Pella® Reserve™ Traditional Hung Window

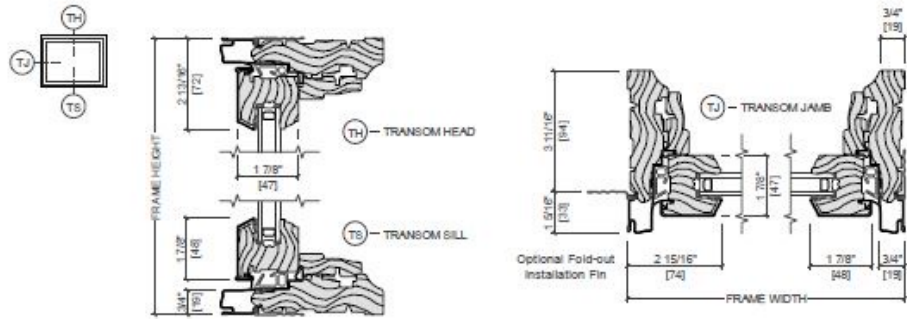
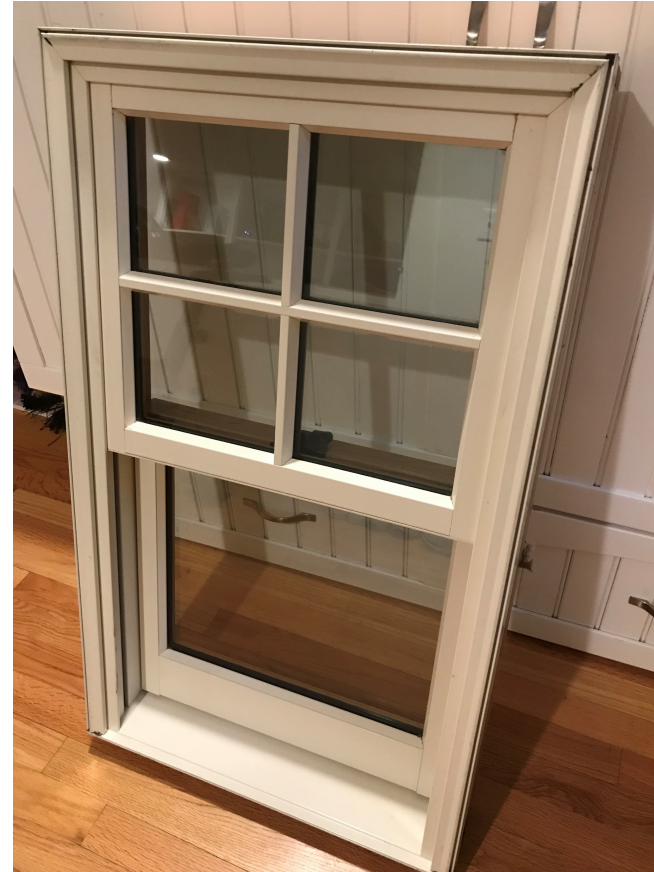
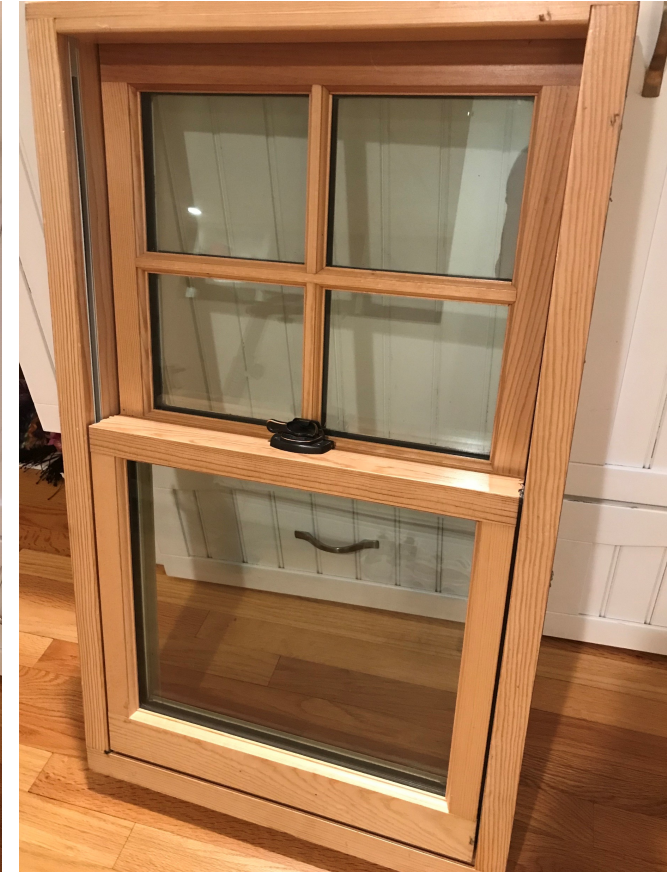
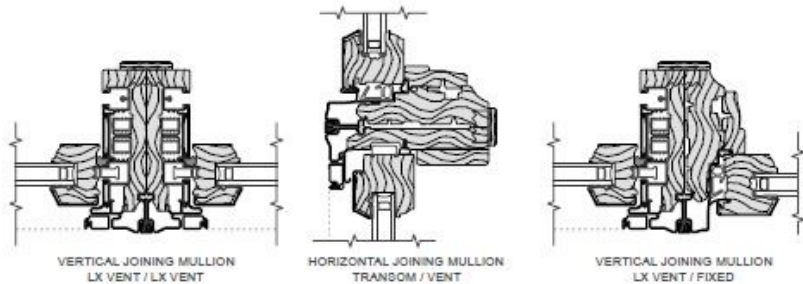
Typical Joining Mullions

Scale 3" = 1'-0"

See supporting document Combination Recommendations, for mullion limitations and reinforcing requirements.
