St. Gabriel's Monastery

THE MONASTERY, BRIGHTON. MASS.

August 23, 2016

St. Gabriel's Monastery Renovation

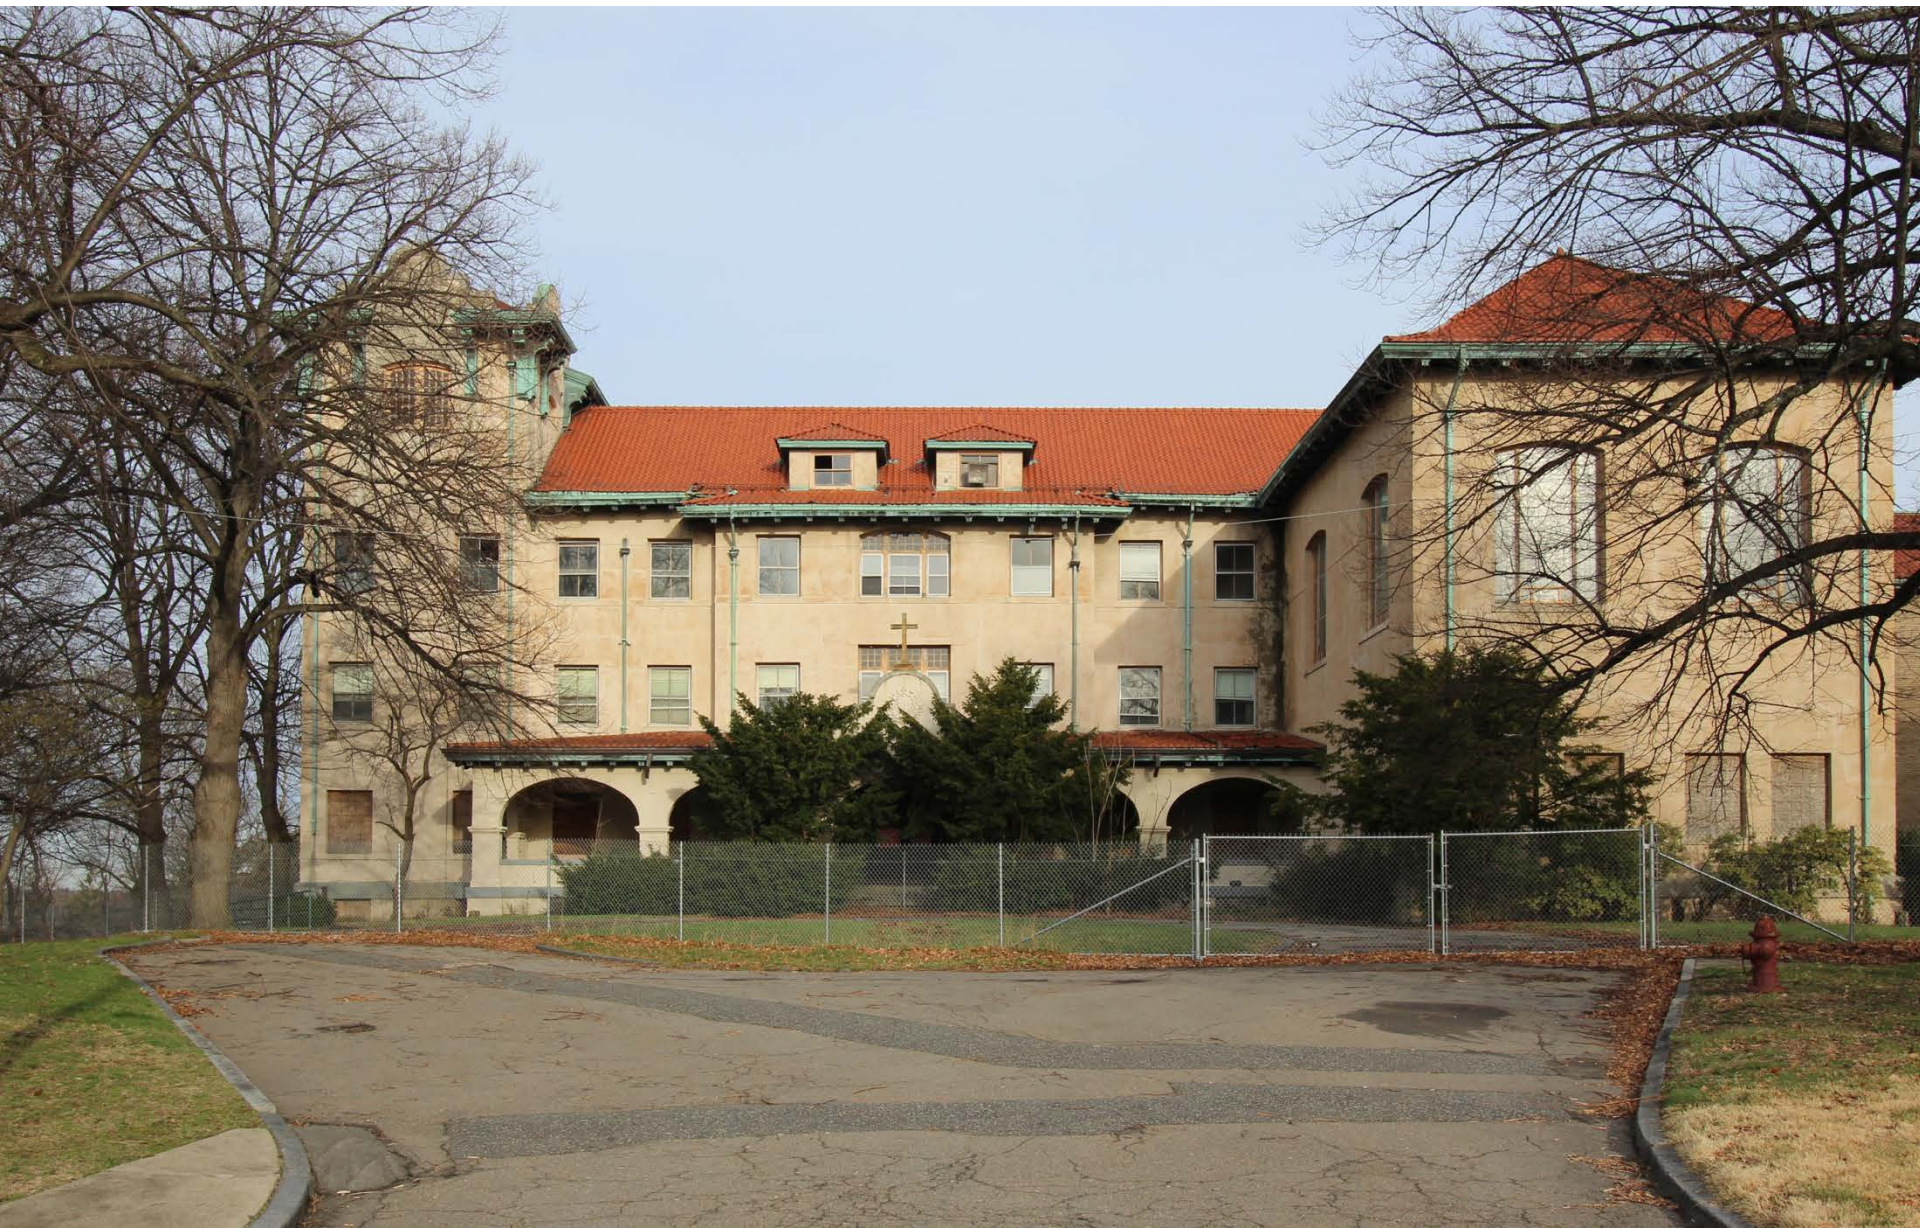
Entry Facade with Chapel on the right.

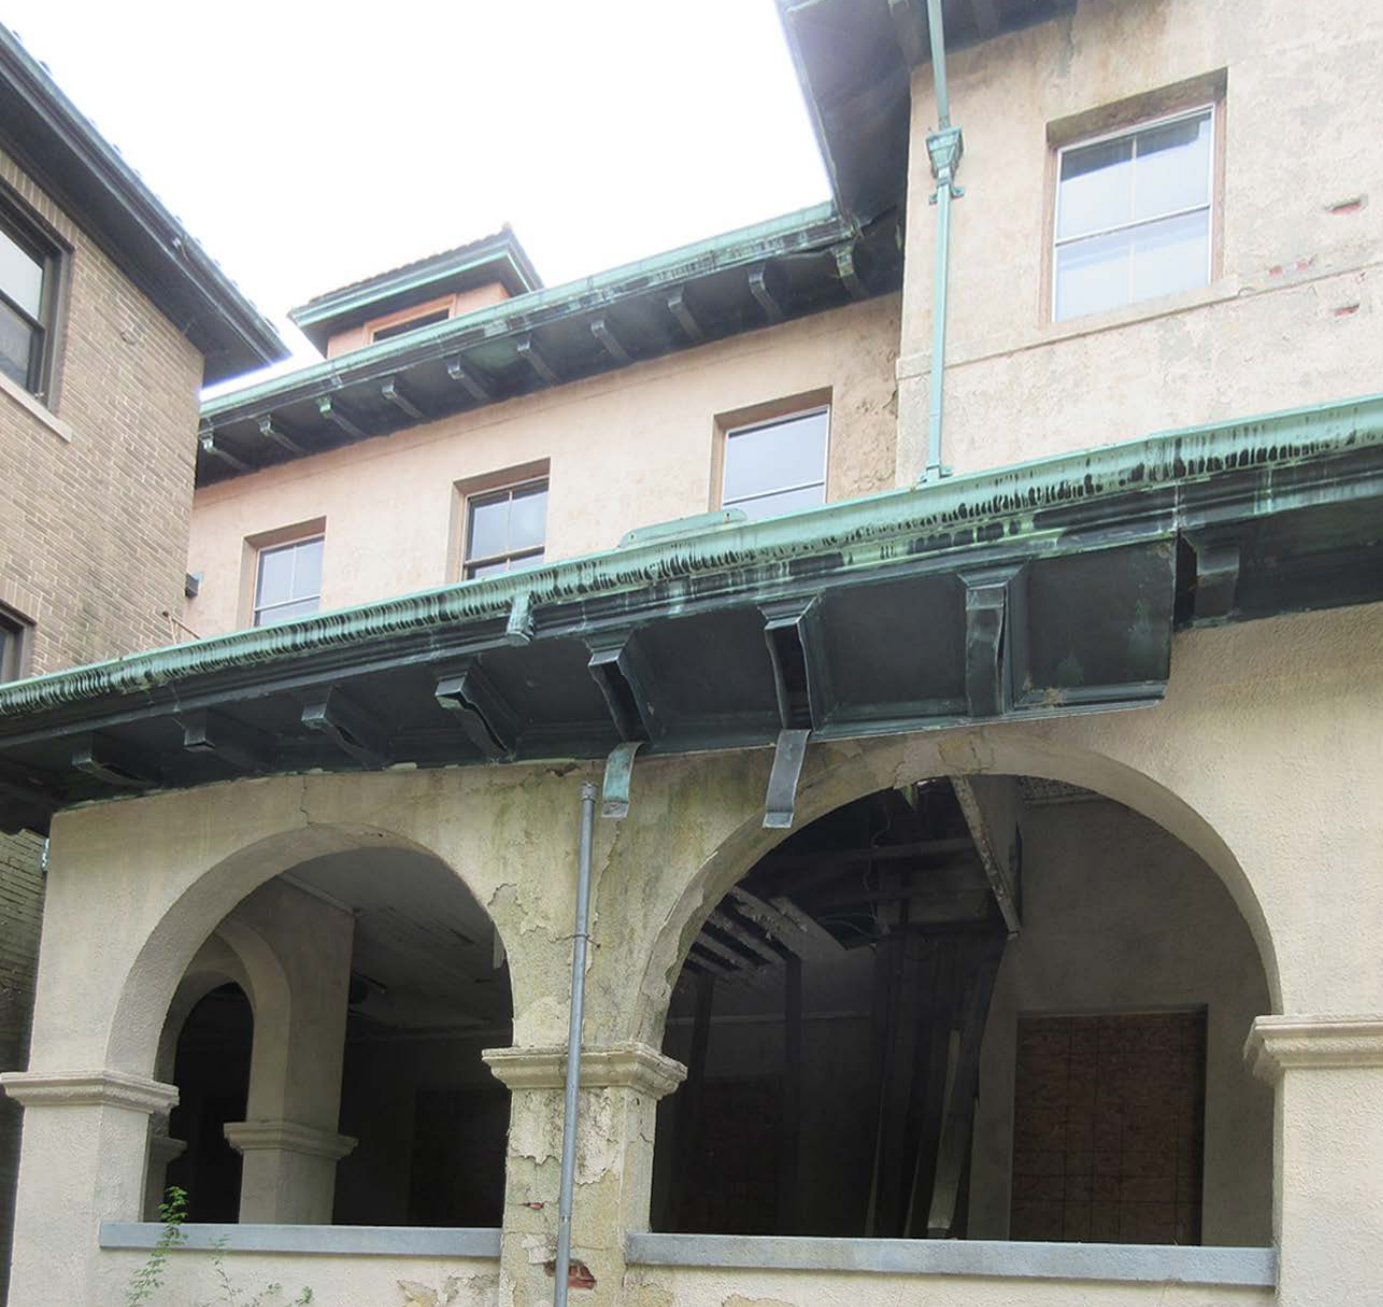
Another example of damaged cornice conditions to be restored. All gutters within the cornice need to be replaced. In general, all gutters here failed and approximately 50% of cornice sections have failed.

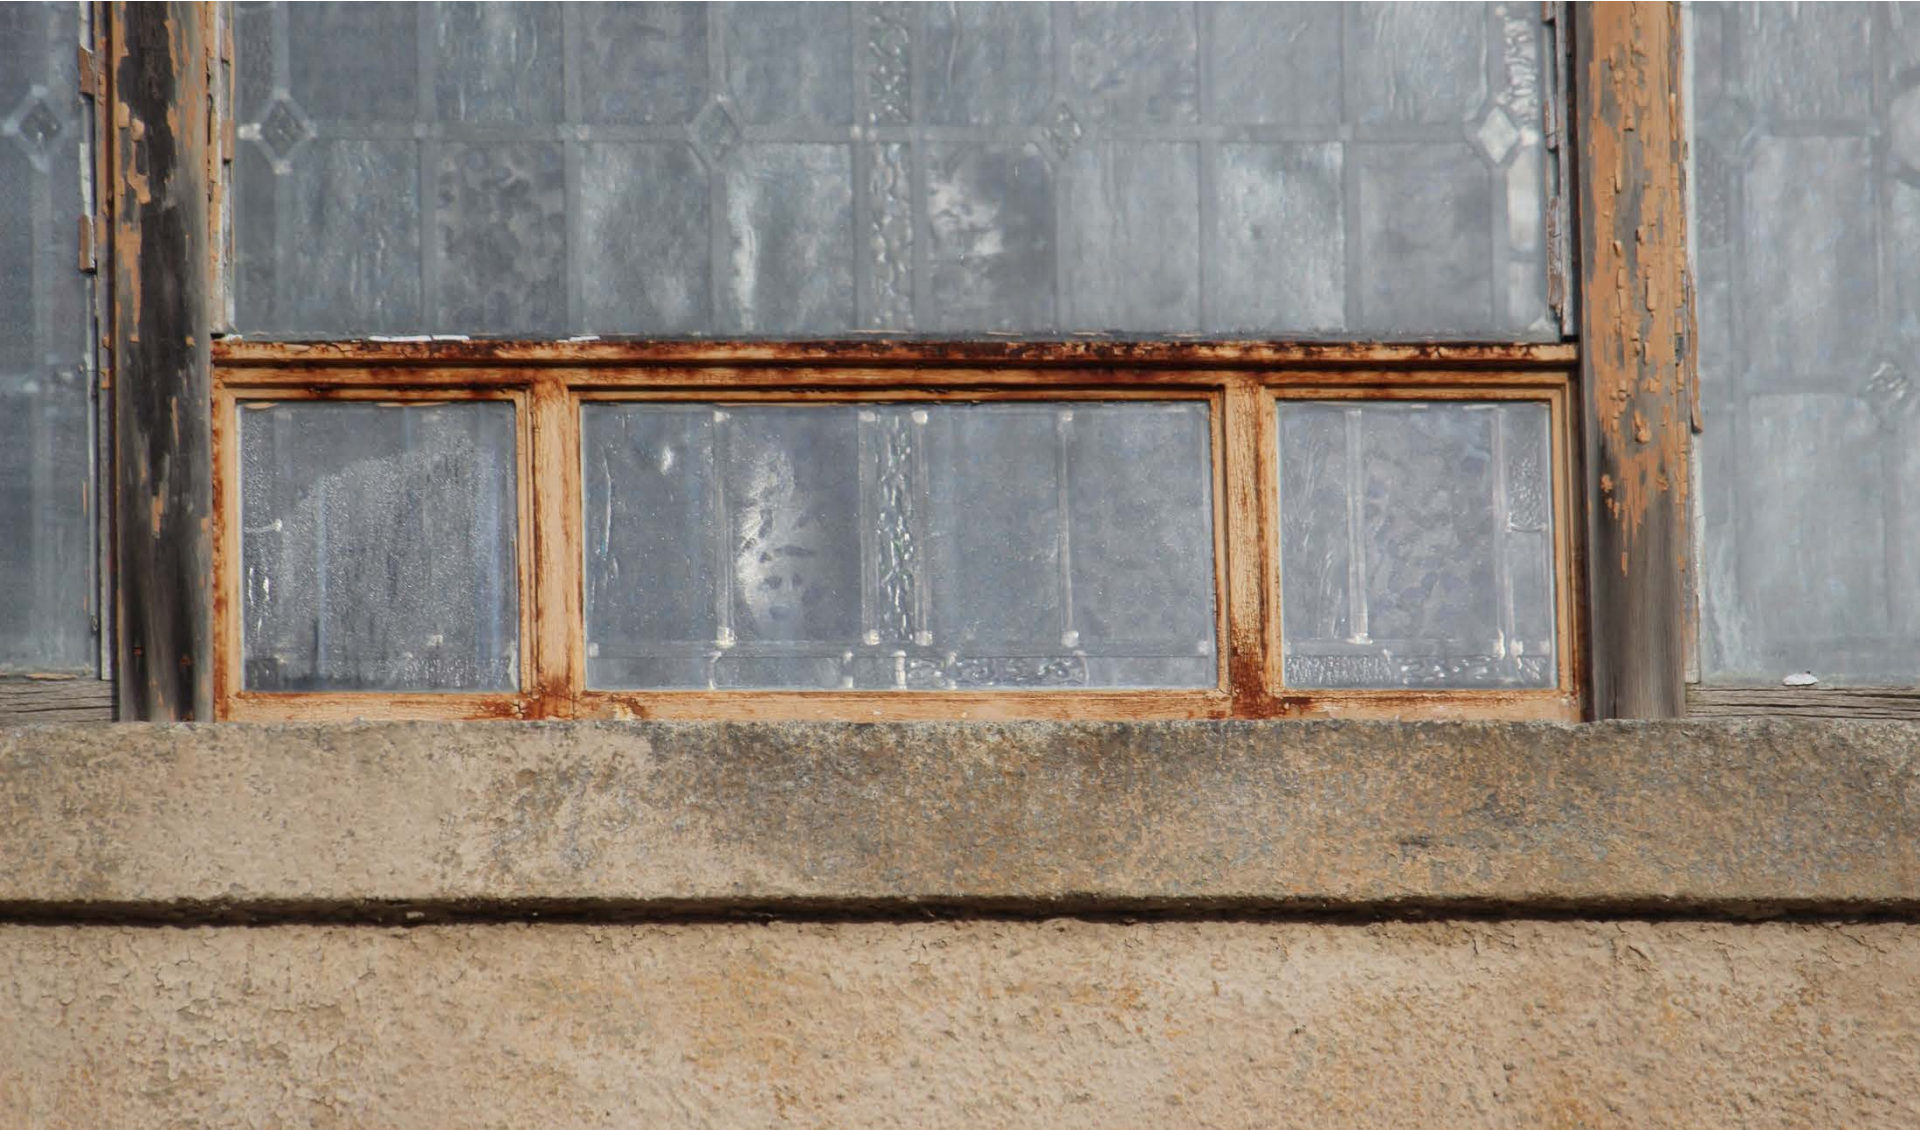
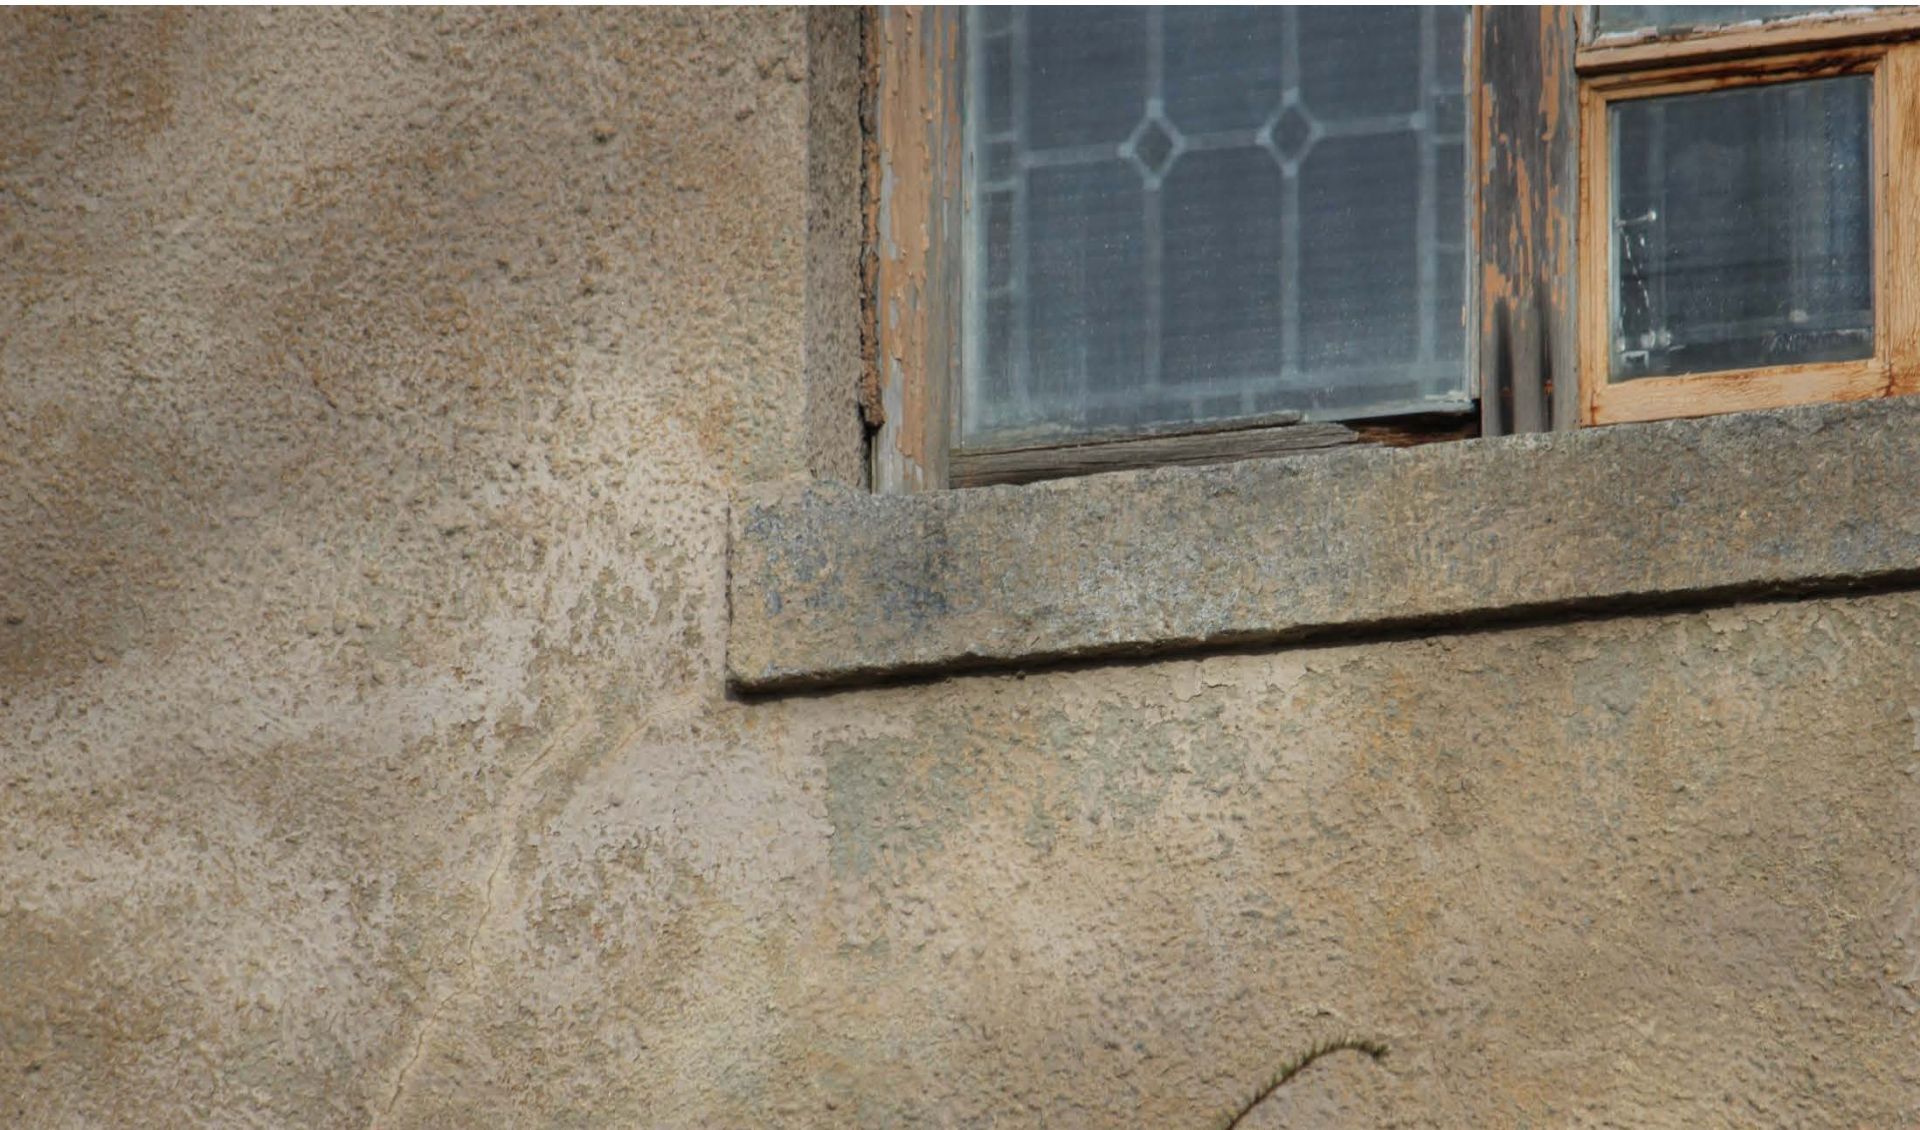
Challenge with window restoration.

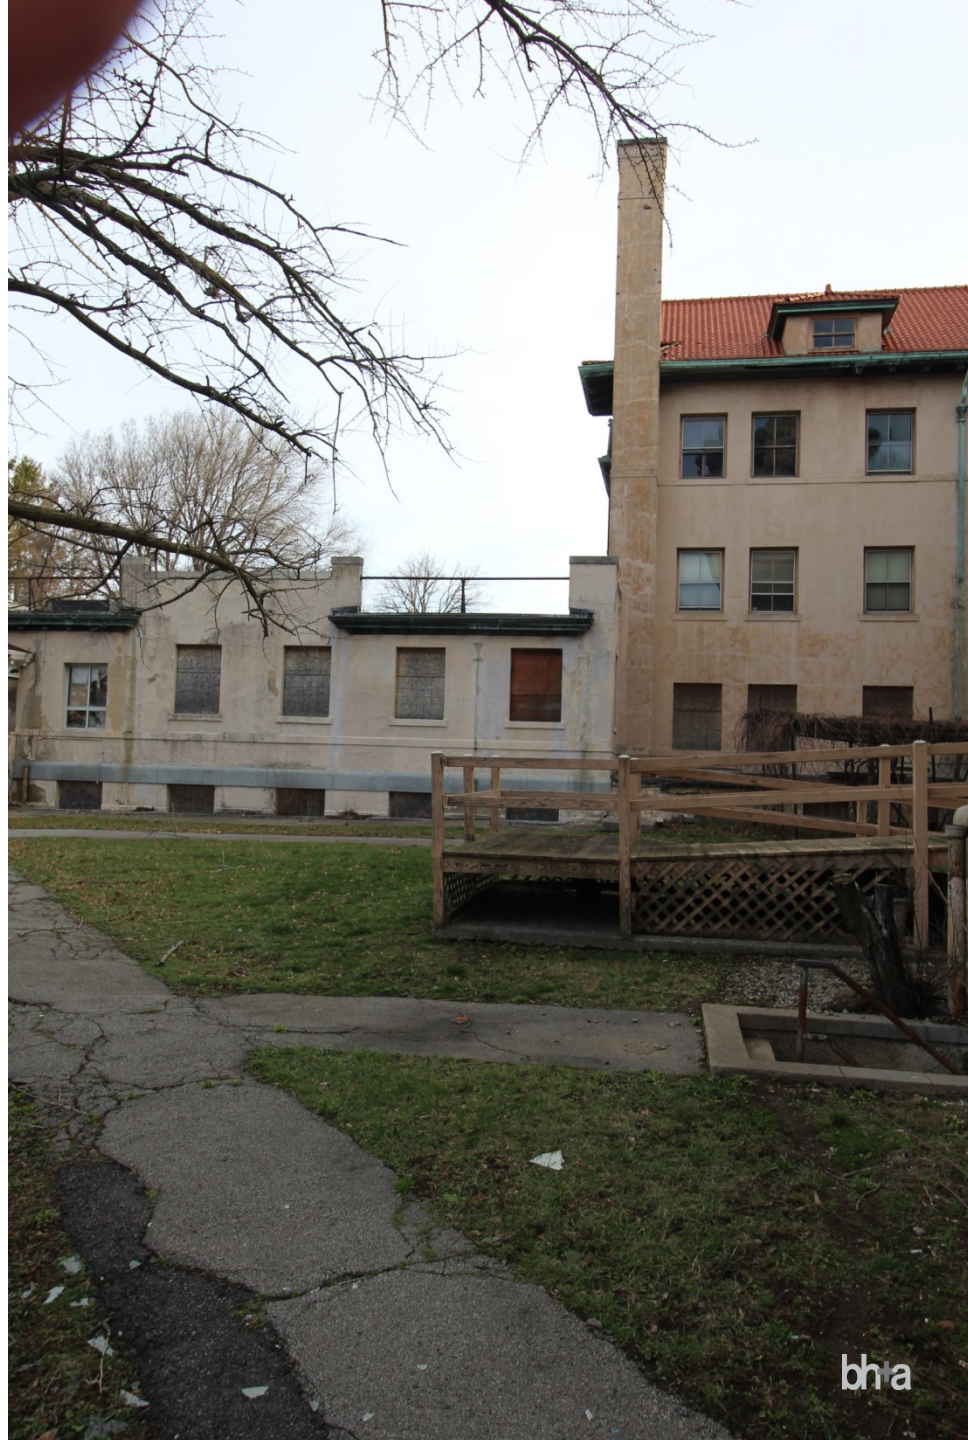
Restoring the North Facade

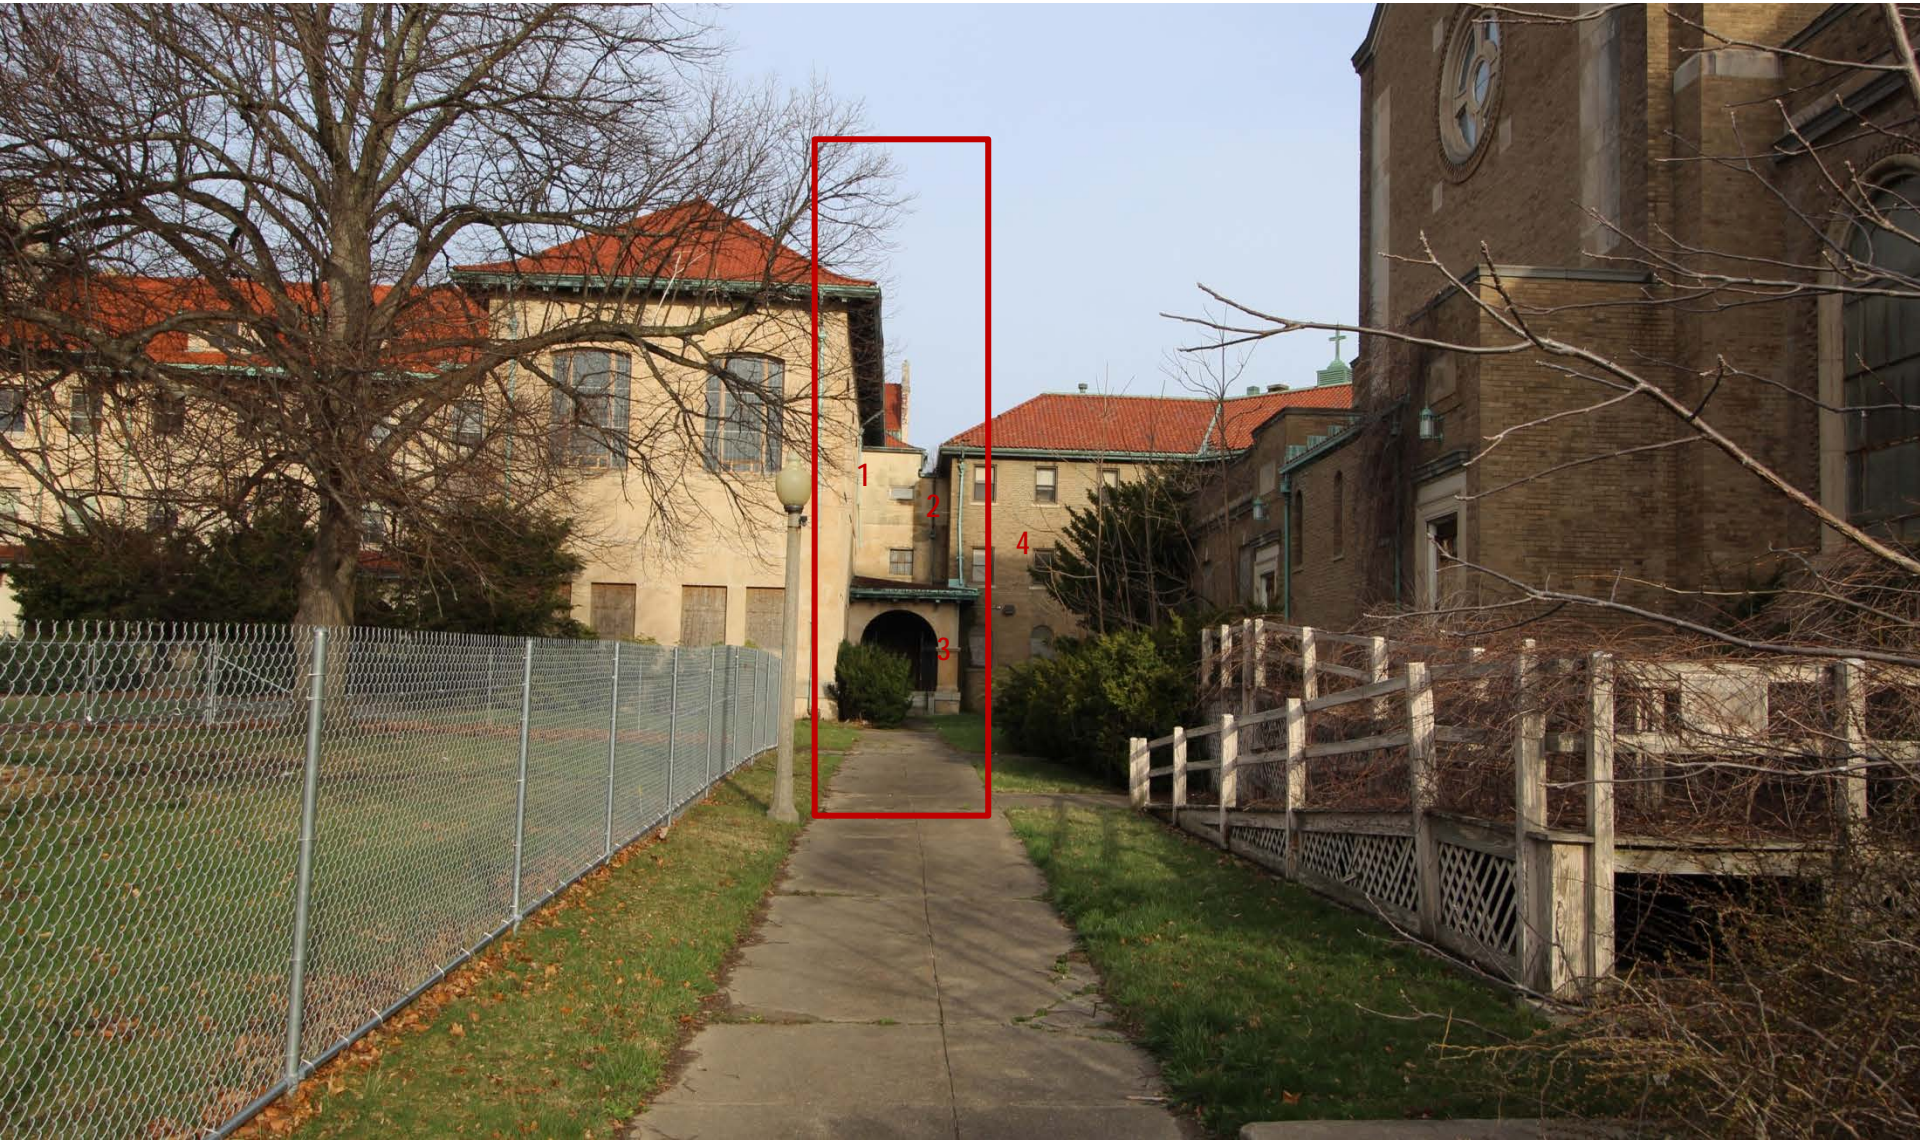
Pruning of "Additions" from Monastery Building will expose proch as it was originally constructed as shown on previous page.

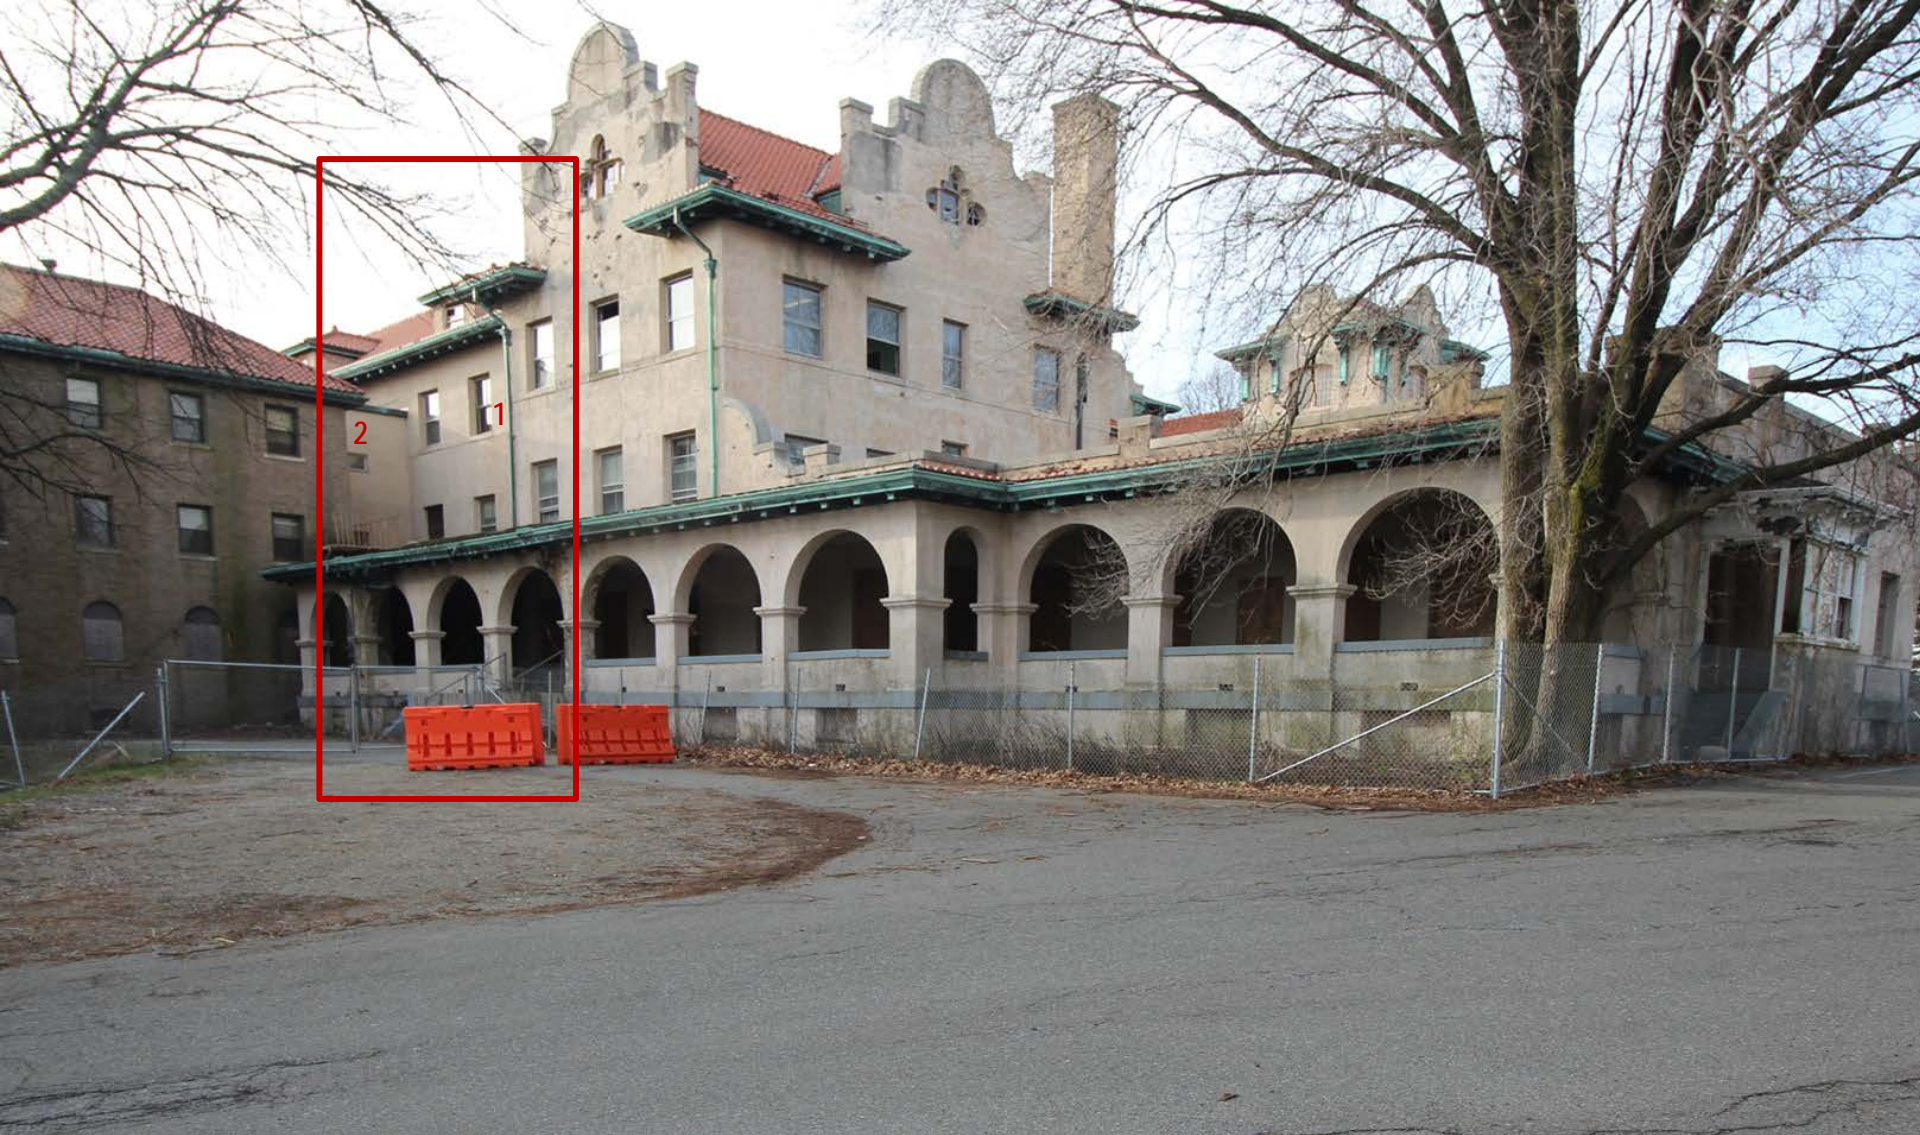
Pruning of "Additions" from Monastery Building and porch treatment. Area where original porch was removed will have porch restored.

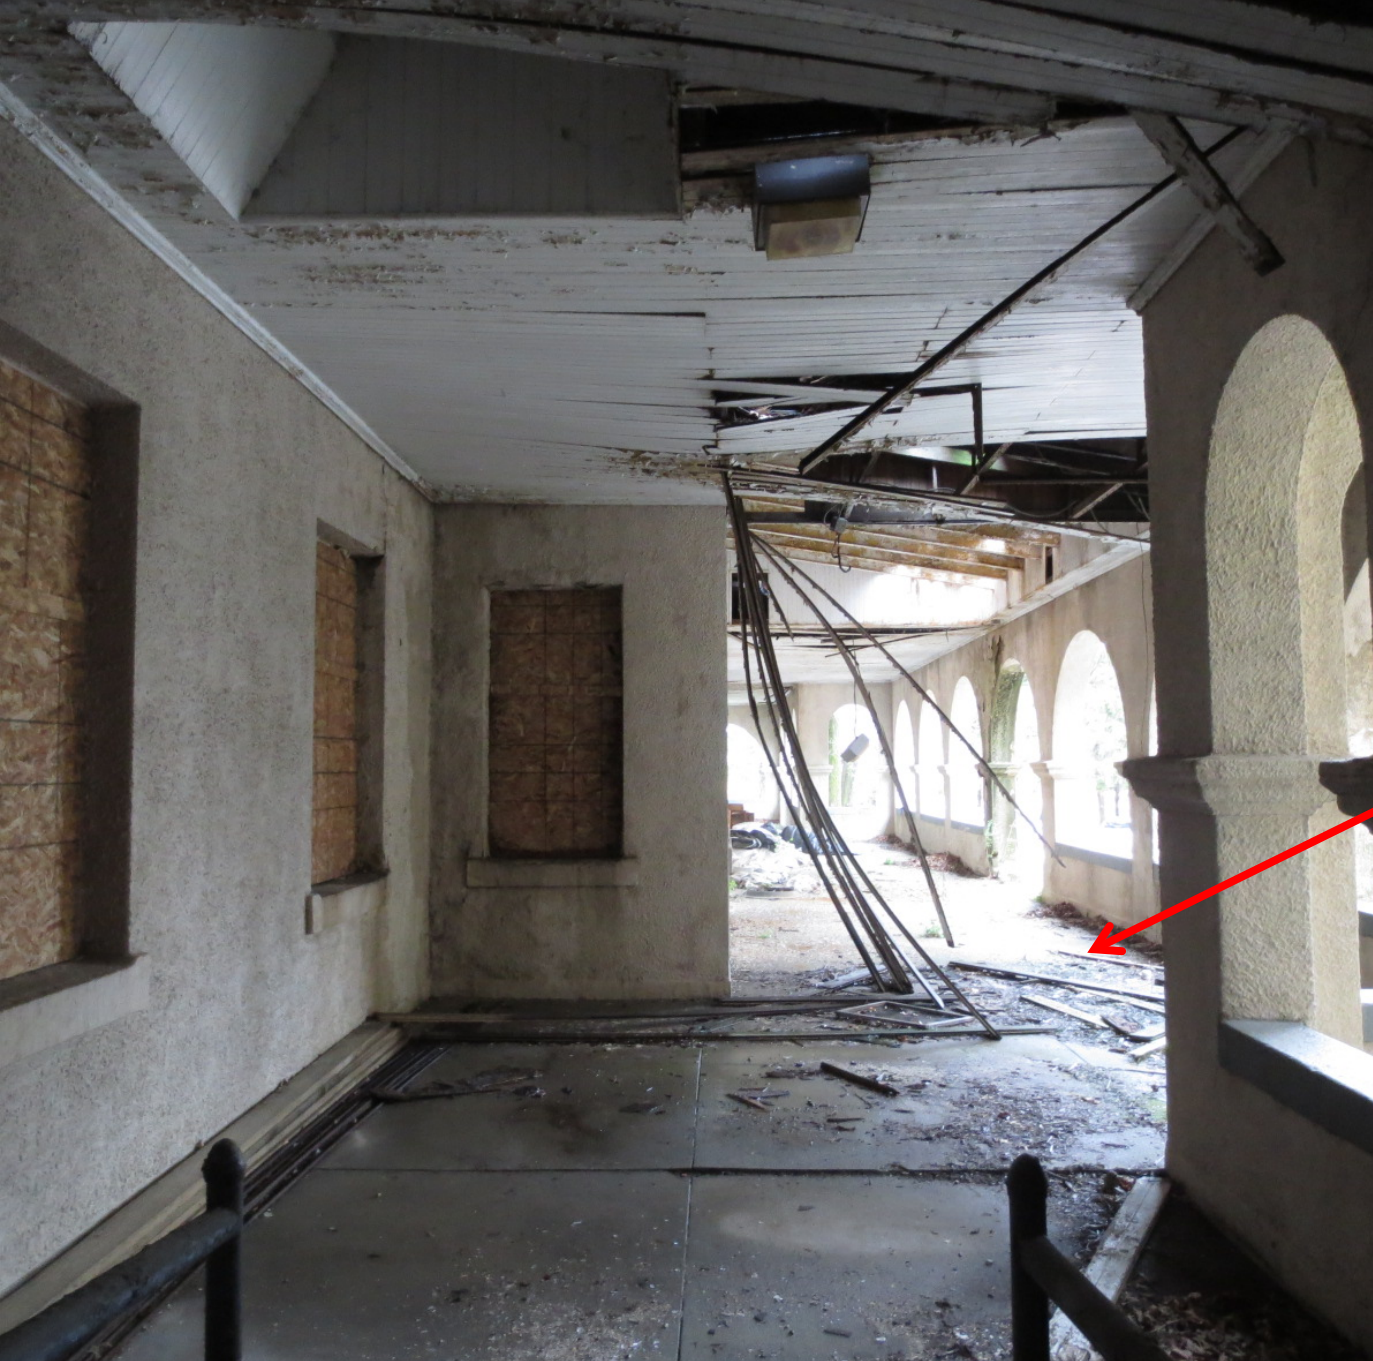
Proposed Accessible Ramp location to be concealed from exterior view.

Interior of north porch to be restored due to massive damage caused by water infiltration. Accessible ramp to be concealed in porch at right side of incase.

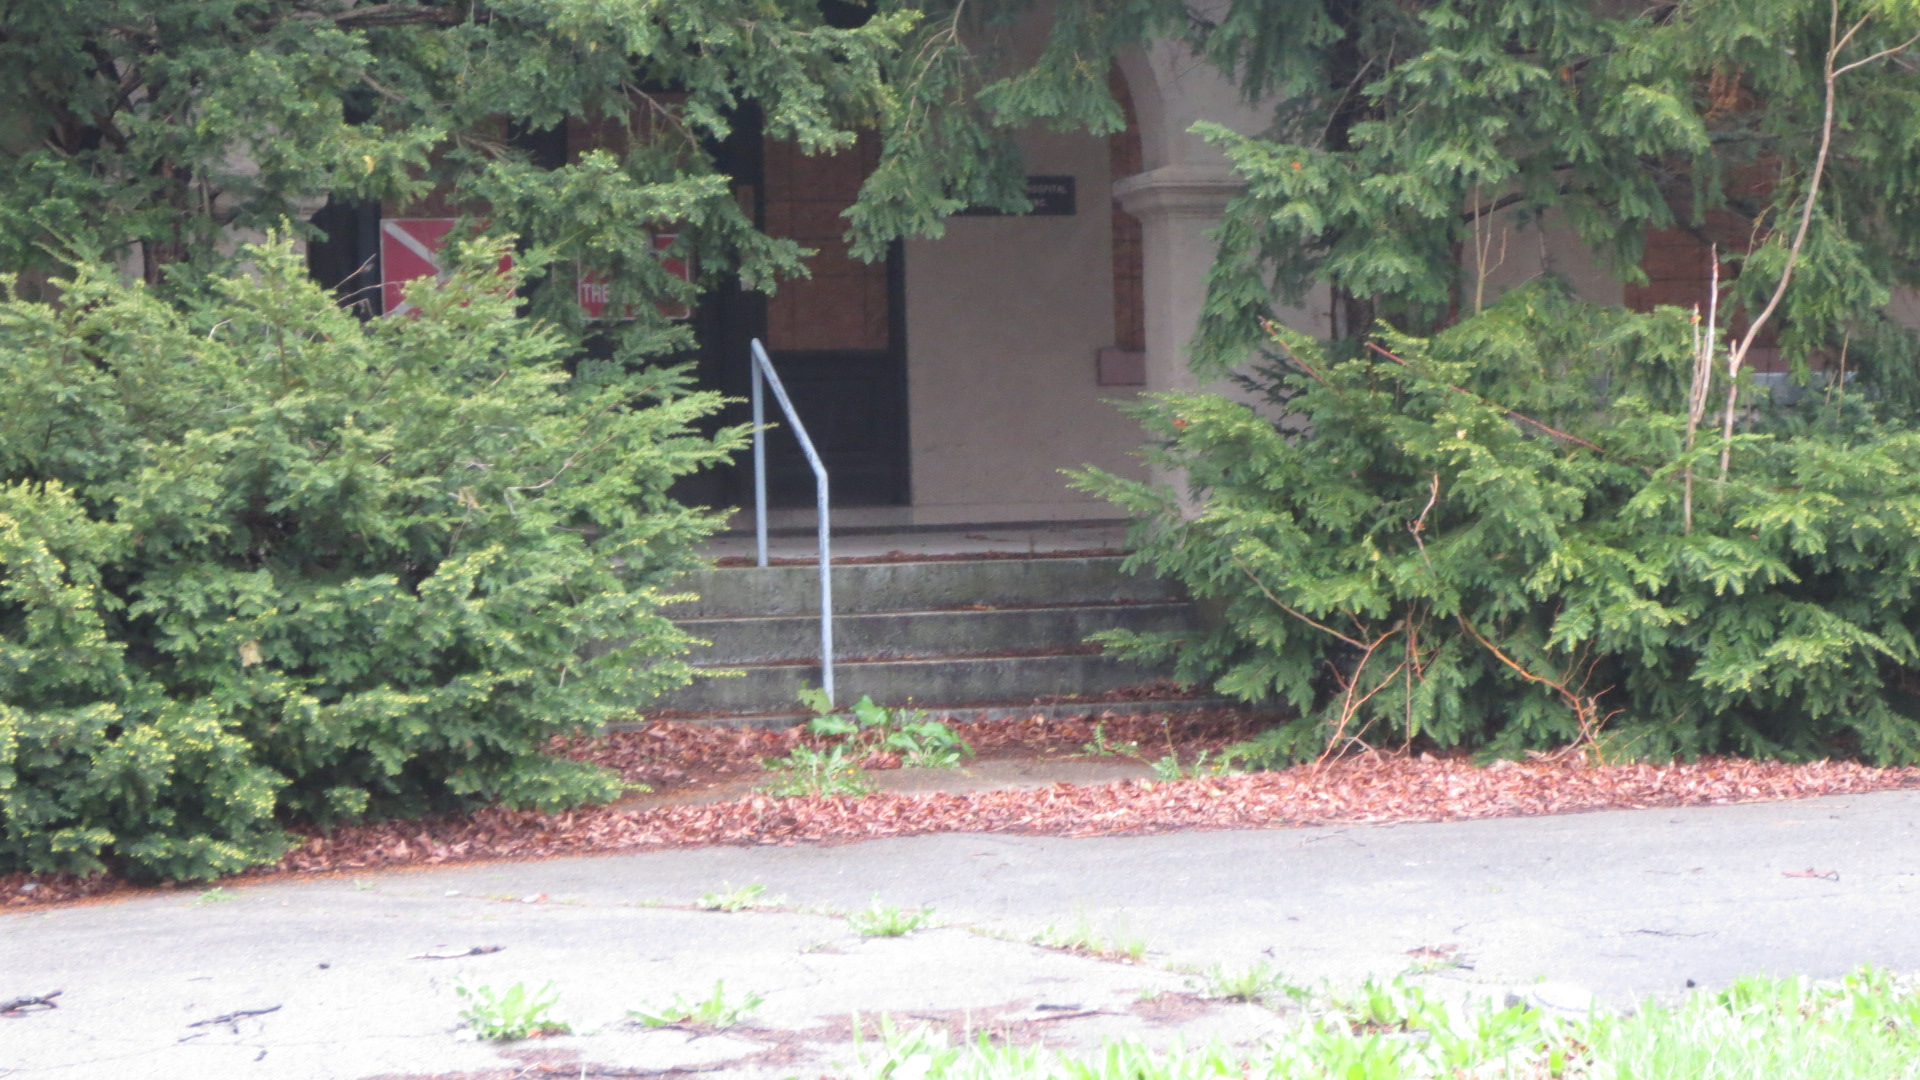
Existing overgrown front entry to Monastery at East Façade is not accessible and will be made accessible. Front Entry doors will be restored.

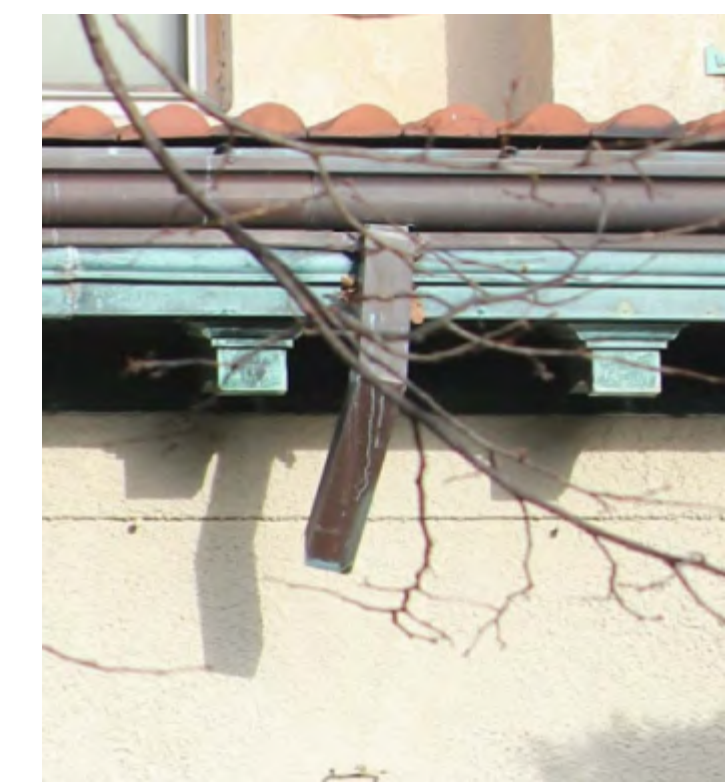
EXISTING REPLACEMENT COPPER TRIM AT PREVIOUS REPAIRS TO FRONT ENTRY PORCH, WITH MISSING DOWNSPOUT

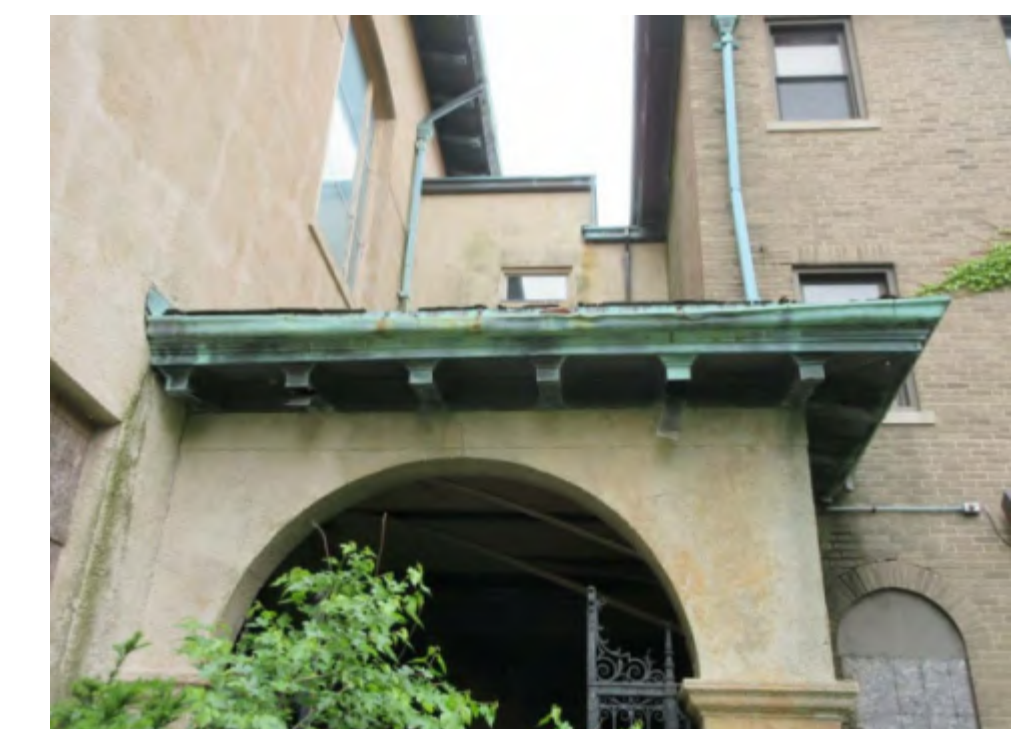
EAST SIDE OF CONNECTOR

STUCCO HAS AREAS OF WATER DAMAGE AND MISSING MATERIAL, BUT GENERALLY SOUND.
