DRAFT 02.16.18

Esplanade Tree Management & Succession Plan

Prepared for The Esplanade Association and Department of Conservation & Recreation 2018

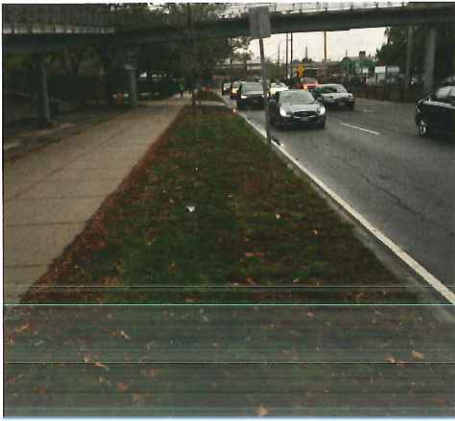
1. Empty street tree site

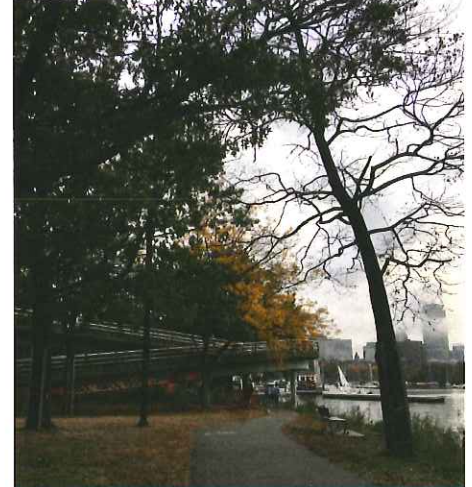
6. Gap in continuous canopy

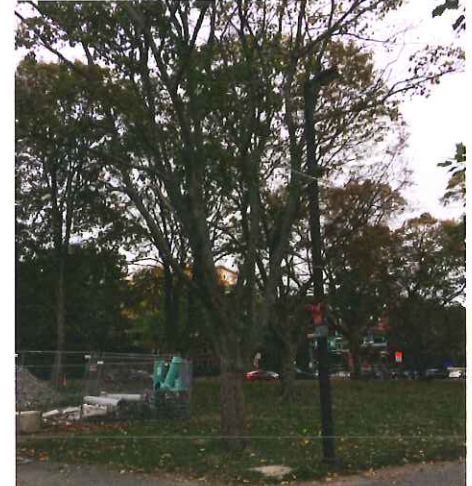
9. Declining mature trees

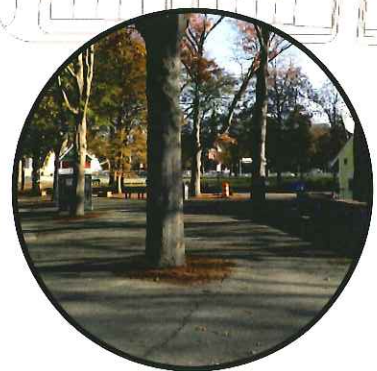
Abandoned asphalt paving still remains in portions of open lawn

Grove with significant pressure from paved area and high use

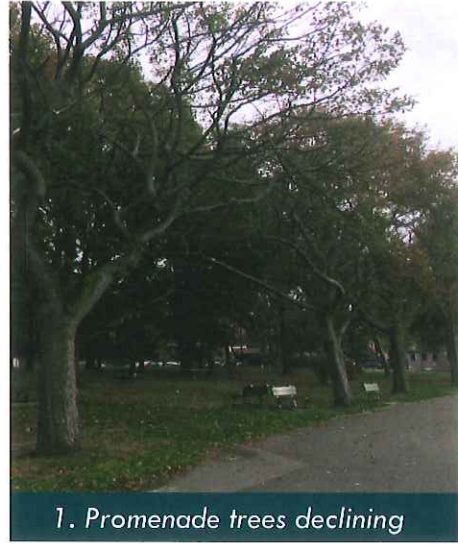
1. Promenade trees declining

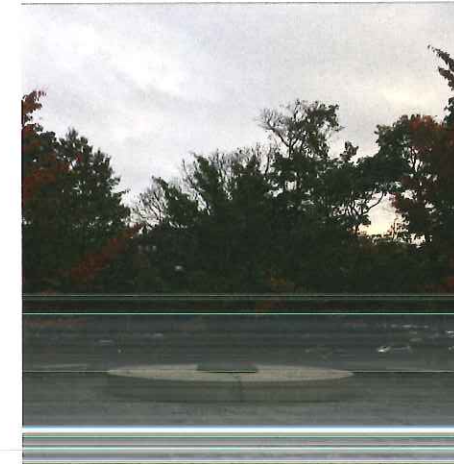
Many tree species are found in small groupings along the Esplanade and at important nodes. One specific problem area consisting of monoculture planting is the Storrow Memorial, where nearly 30 Norway maples are in declining health. In 2015, 19 of these trees were listed as “poor condition”, due to issues such as girdling roots, stem lean, codominant leaders, and decay. These trees are planted in a formal grid pattern, forming continuous canopy coverage. It is important to note that Norway maples are declining across the Esplanade, with 35% being listed as poor condition in 2015.

2. Storrow Memorial

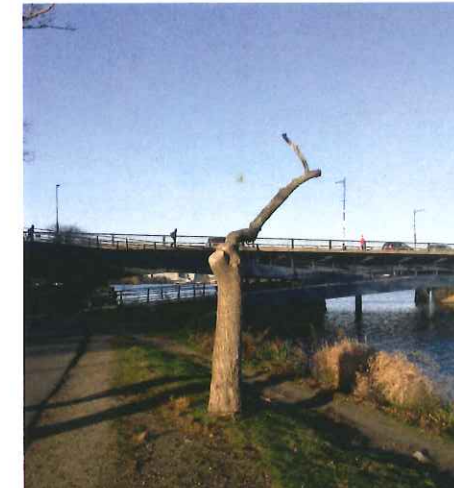
5. Dead tree should be removed

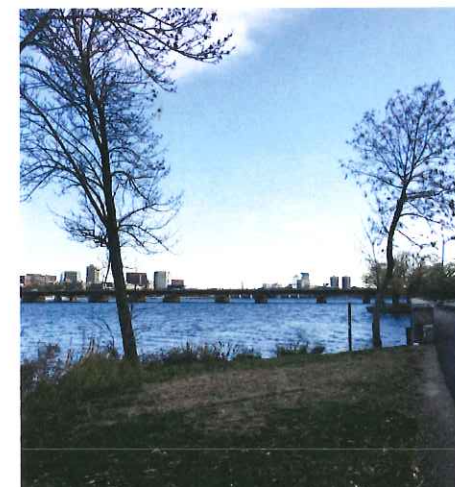
7. Clearing in trees opens a vista

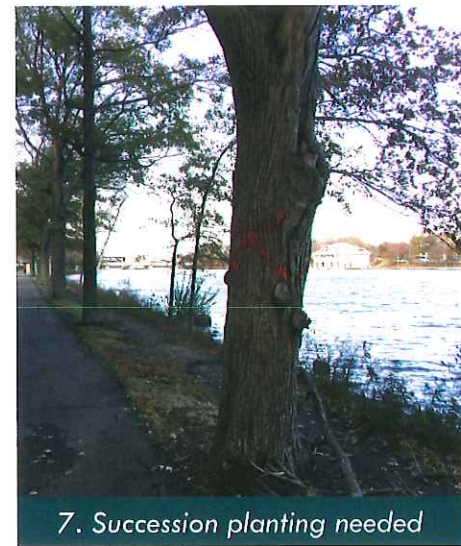
7. Succession planting needed

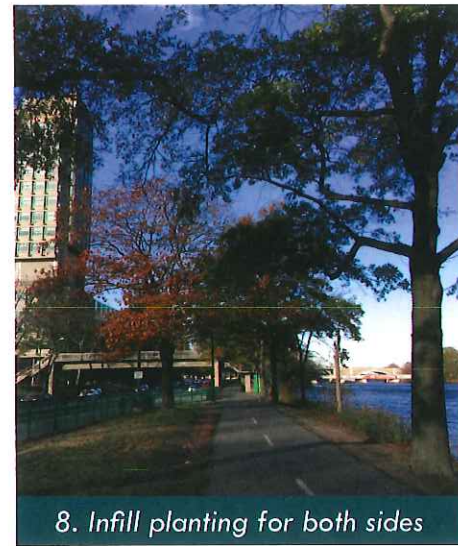
8. Infill planting for both sides

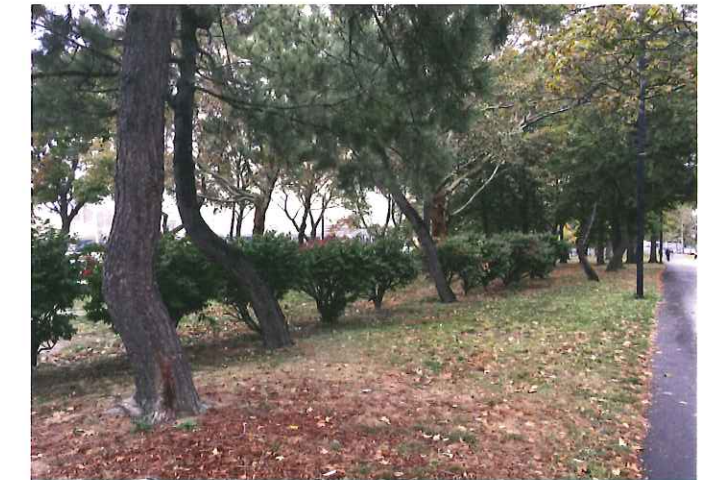
Vegetative screen of burning bush

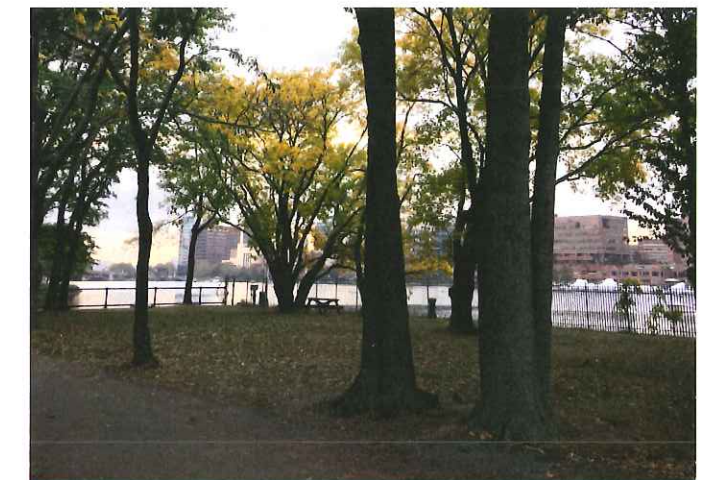
Volunteer species occupy and open space

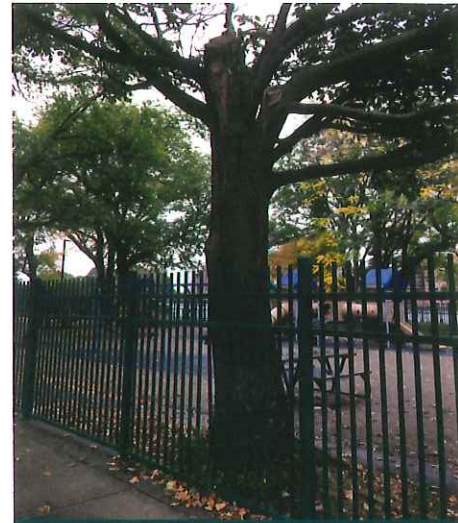
Large Pruned Limbs

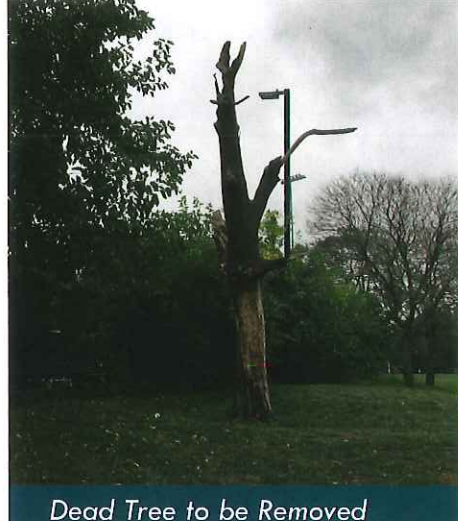
Dead Tree to be Removed

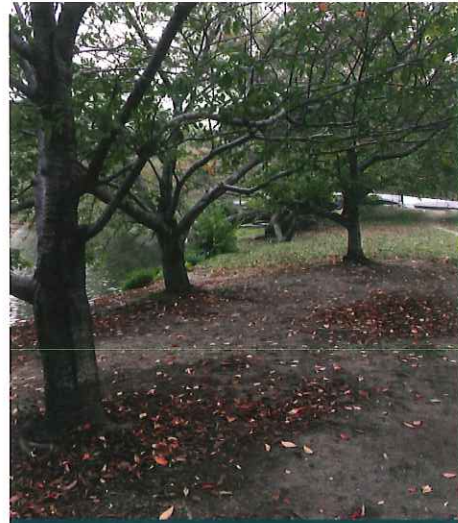
Compacted Root Zones

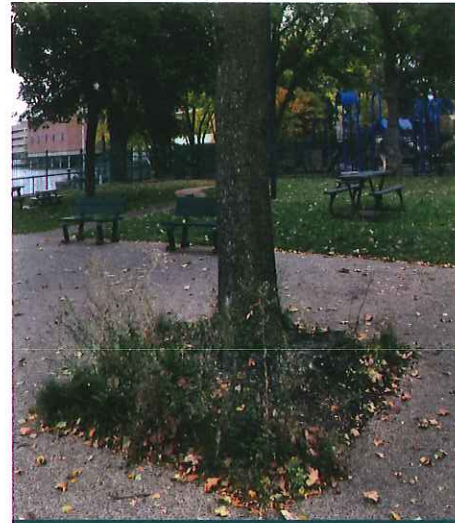
Tree Pits

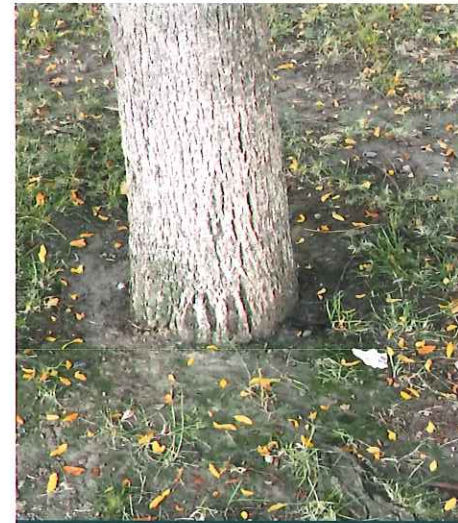
Buried Root Flare

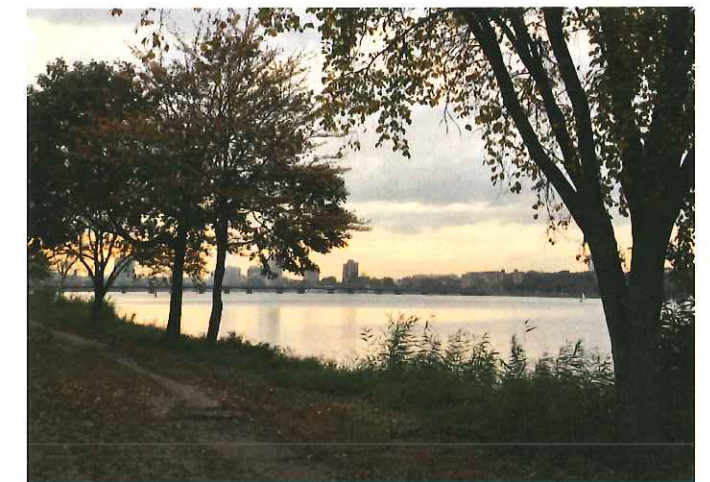
Trees are not formally spaced along Charles River

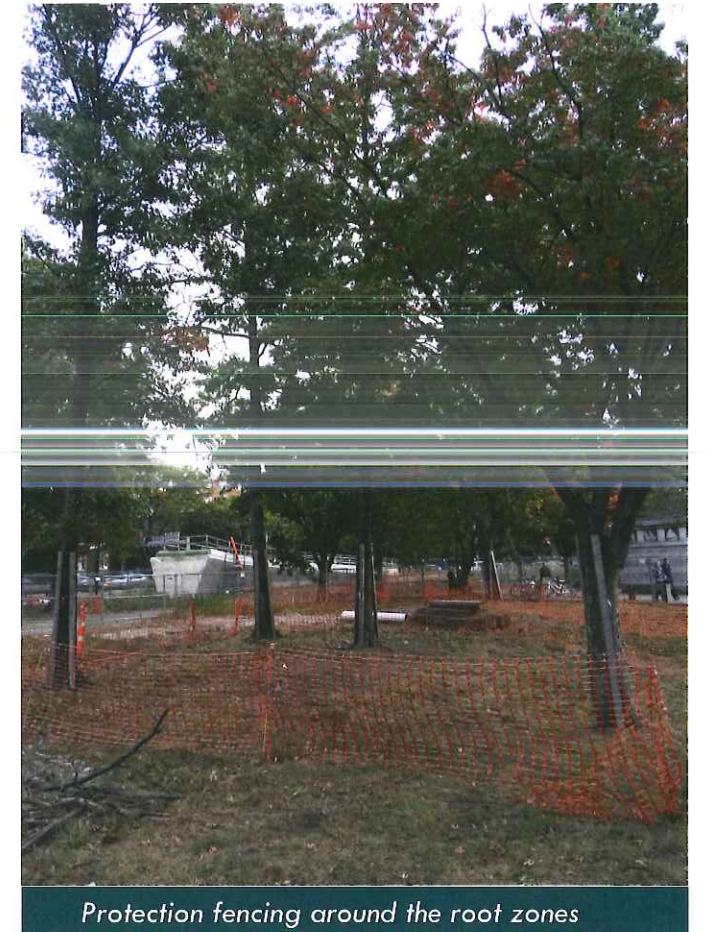
Protection fencing around the root zones
