**CHARLES RIVER SPEEDWAY
BOSTON LANDMARKS COMMISSION APPLICATION**

Date: MARCH 5, 2019

1420-1440 SOLDIERS FIELD RD
BOSTON, MA 02135

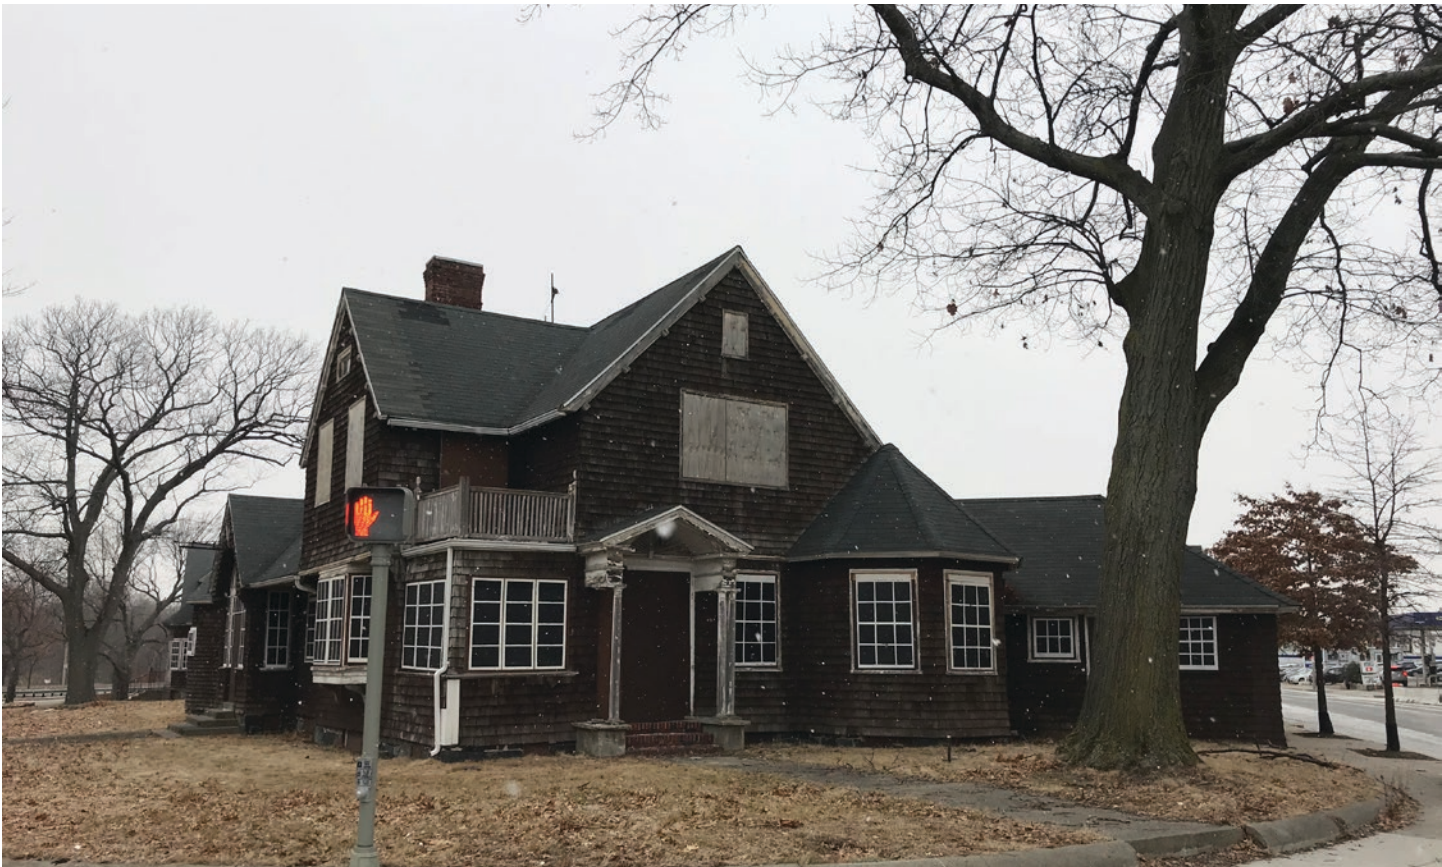
Figure 6: Building F Exterior

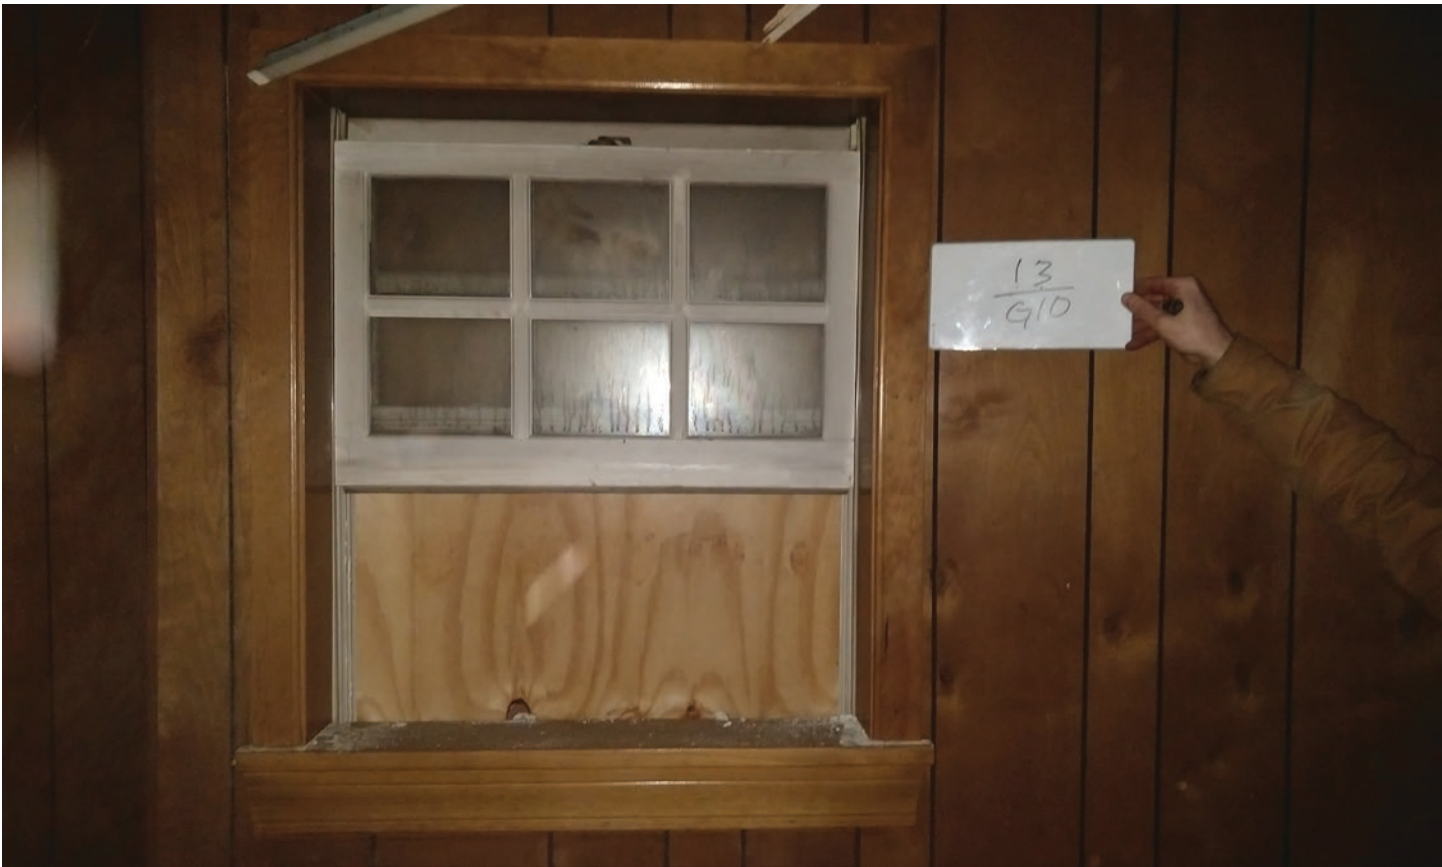
Figure 40: Building F Window at Sliding Courtyard Door

At Building F, intact original windows will be restored. Damaged sash will be replaced with new sash to match the originals. The windows at the sliding door in shed portion of Building F facing the upper Courtyard will be restored. One bulkhead basement access will be removed and the opening will be glazed as re-grading allows.

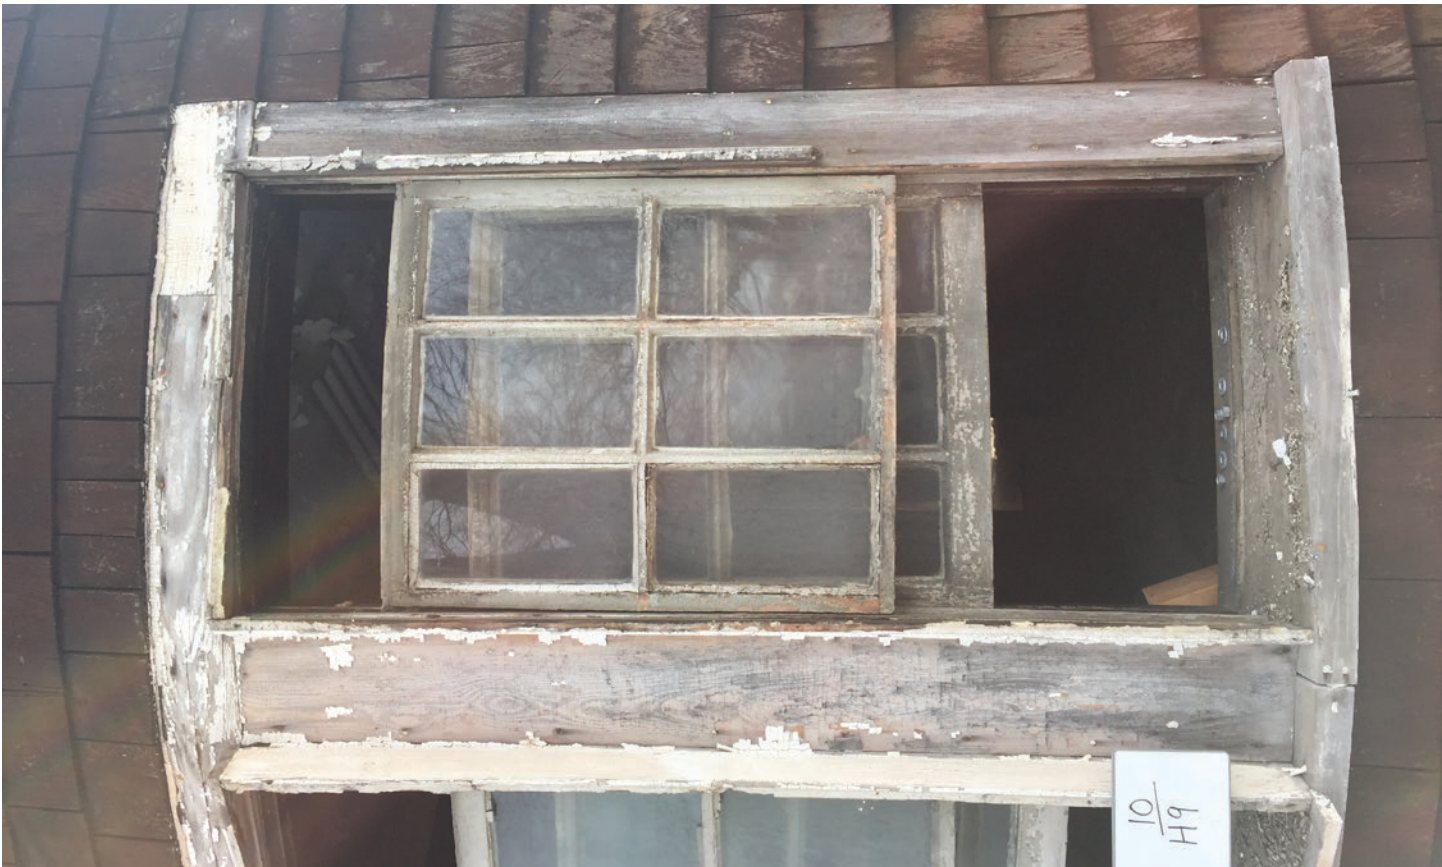
Figure 44: Building G Barred Window at Jail

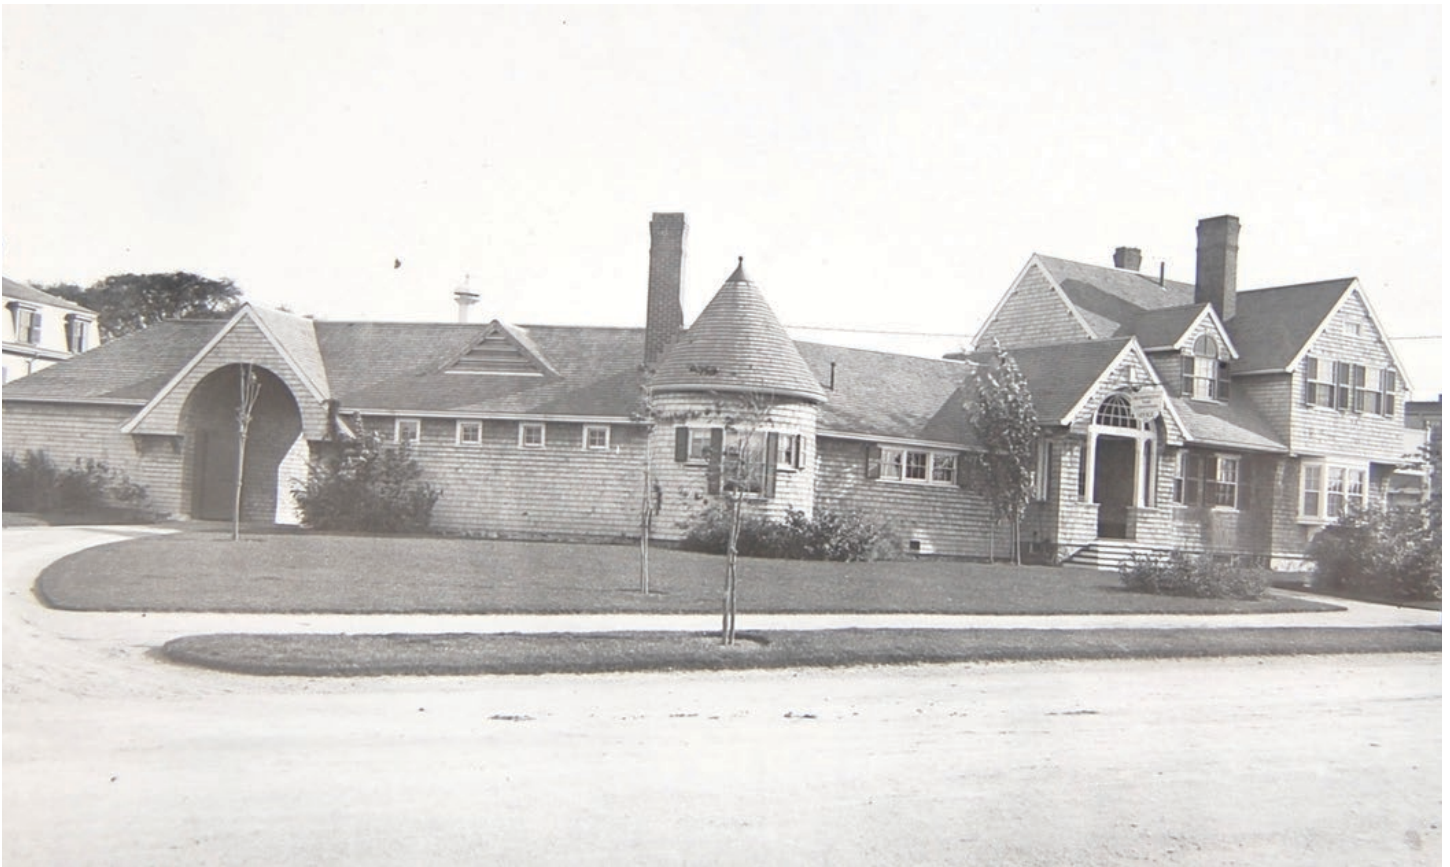
Figure 48: Building H Basement Hopper Window

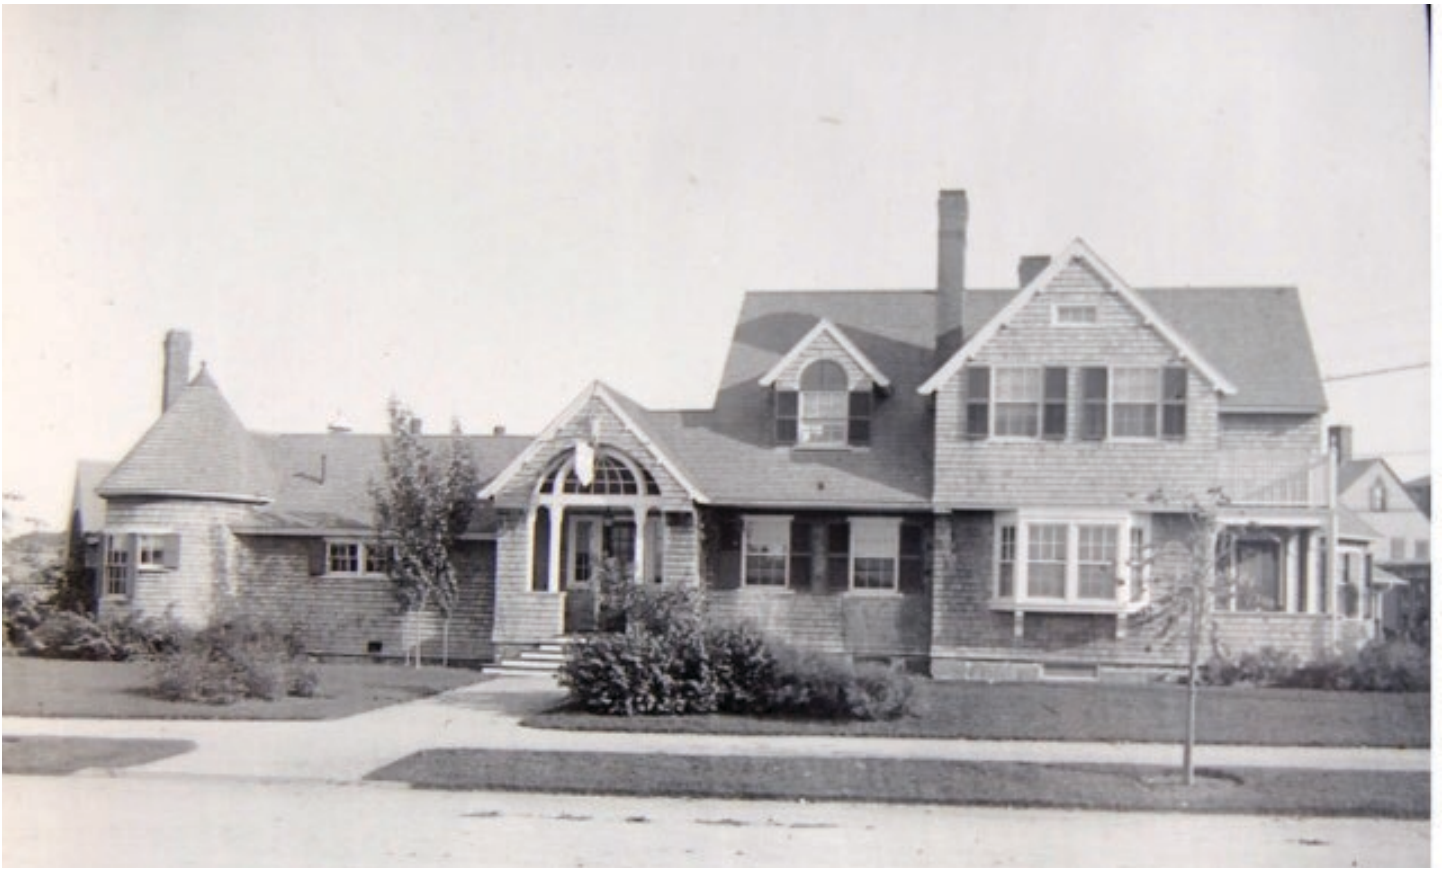
Figure 86: upper Courtyard Photo cir. 1946

In figure 86, it is apparent that at least one large scale lamp was installed to illuminate the upper Courtyard. Any additional exterior lighting has either been removed, or none was provided.
